Town of Beaverlodge

Arena Condition Assessment

FEBRUARY 2023

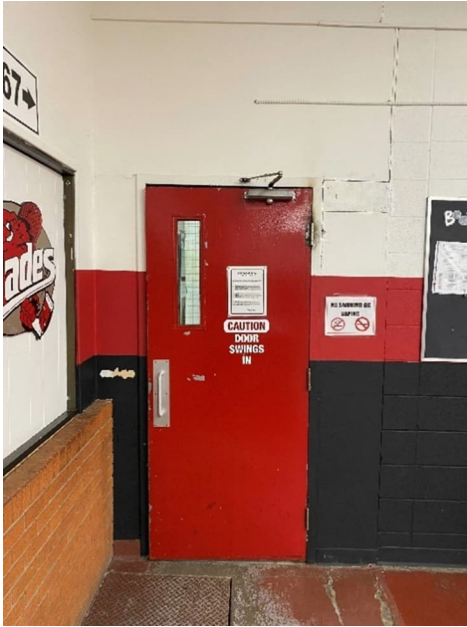
Figure 2-1 Replace Damaged Door and Framing

- Rebuild and repair the fire separation between the lobby and the rink to meet the 1 hour required F.R.R.
- Patch and repair penetrations through rated wall assemblies.
- Replace doors between the rink and the lobby and rebuild the rough opening.
- Install fire ratings on doors as per NFPA 80.
- Install a vestibule into the ice plant to meet the required separation.

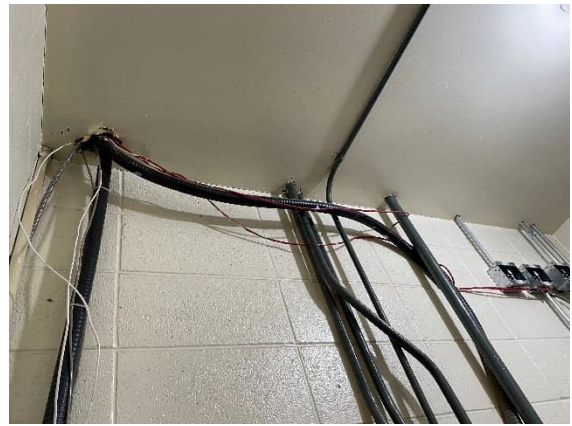
Figure 2-4 Penetrations Through Rated Assembly

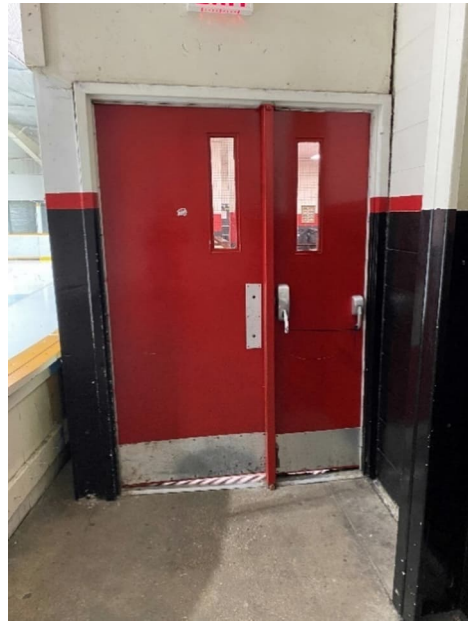
Figure 2-6 No H.C. Access Button

- When renovating the building update non-compliant code issues.

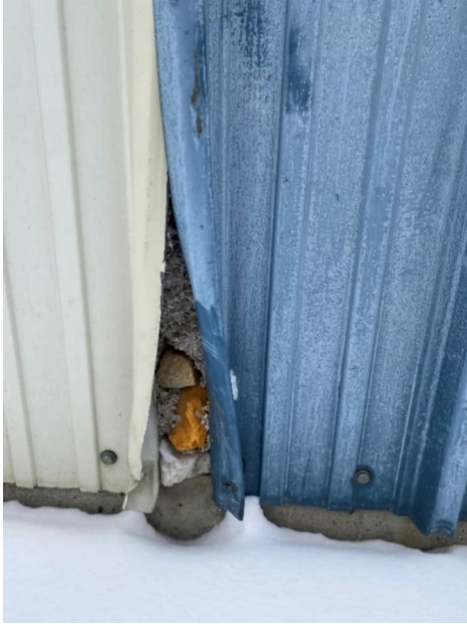
The exterior metal cladding is discolored, faded, and has rust in various locations. The rubber washers holding the cladding to the girts are stiff and brittle and need to be replaced. Metal cladding has a typical lifespan of 50 years and is also at the end of its lifespan.

Figure 2-9 Damaged Exterior Cladding

Replace the existing metal cladding and building envelope around the rink. It is recommended to install insulated metal panels or a similar system outboard of the existing girts to reduce the thermal bridging.

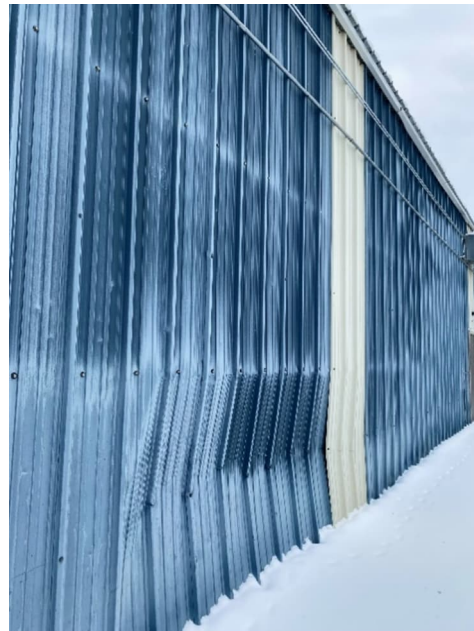
Figure 2-10 Damaged Exterior Cladding

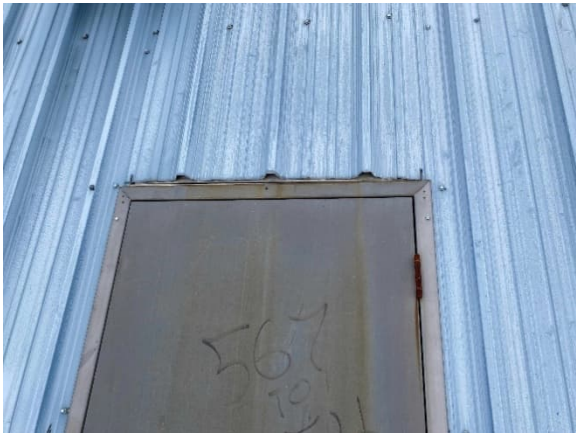
Figure 2-11 No Flashing Over Exit Door

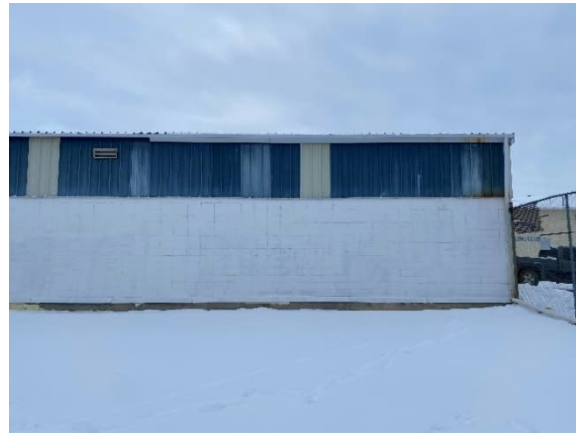
Figure 2-12 Rust Visible on Southwest Corner

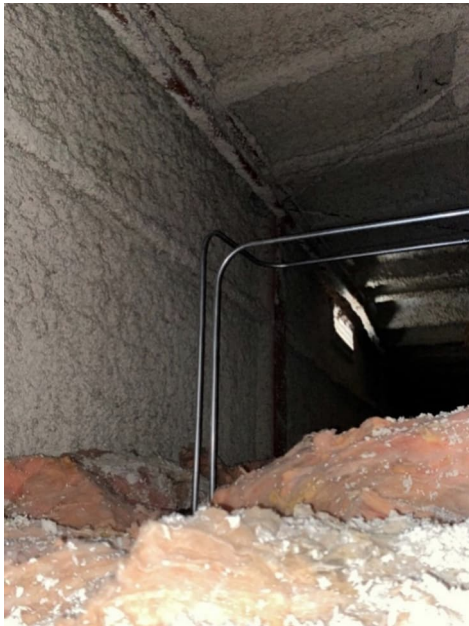
The cellulose insulation above the lobby area is starting to flake off the walls and ceiling and is a sign that the insulation has passed its lifespan and is starting to fail. This failure will cause additional moisture issues in the roof and walls due to the reduced capacity for the insulation to deal with migrating moisture through the walls.

Figure 2-13 Cellulose Insulation Visible on Fiberglass Insulation

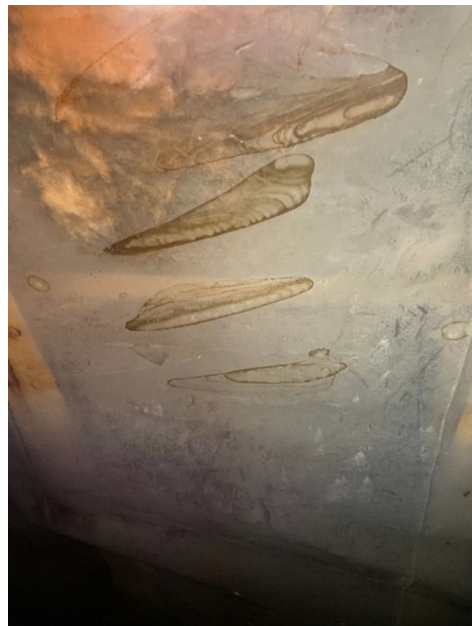
- The insulation above the lobby area has a lot of water damage, and the vapour barrier has water stains.
- The vapour barrier is not sealed properly with tape and sealant at joints in the lobby.
- The vapour barrier is punctured, torn, and cut in various locations and has several large holes.
- There is a hole through the gypsum board ceiling that punctures the vapour barrier in the storage room that requires patching.

Figure 2-14 Water Stains on Fiberglass Insulation

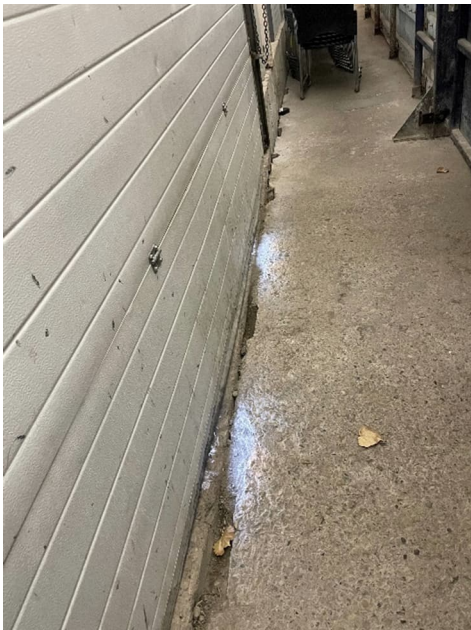
Figure 2-21 Concrete at Overhead Door Requires Patching

It is recommended that the warm slab be replaced because of the need to extend the rink to NHL standards requires the removal of some of the concrete and the bleachers. This will also allow for the area to be leveled out eliminating the need to steps at the exit doors.

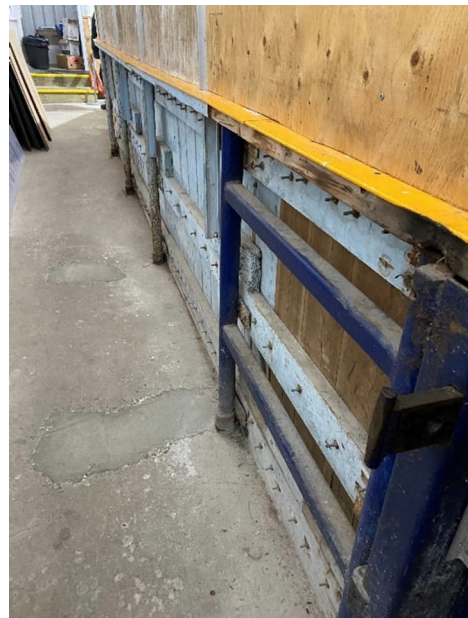
Figure 2-22 Patches in Concrete

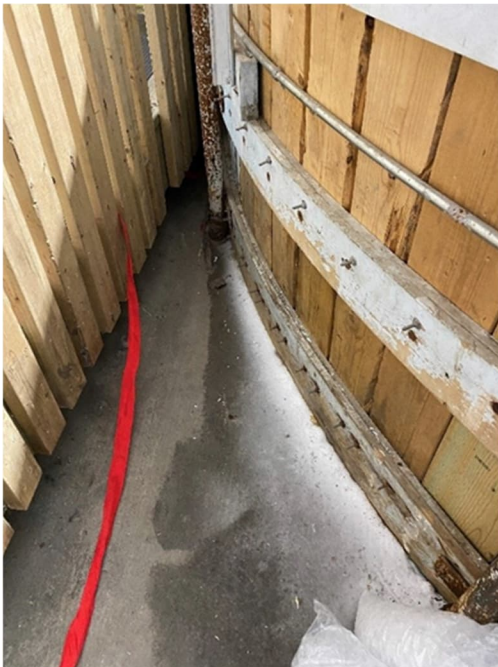
Figure 2-23 Ice Build-Up Outside of Dasher Boards

It is recommended that new dasher boards be installed with the installation of a new concrete rink slab. It is not advisable to reuse the existing boards with a new slab especially if the rink is intended to be expanded to accommodate an NHL sized ice surface.

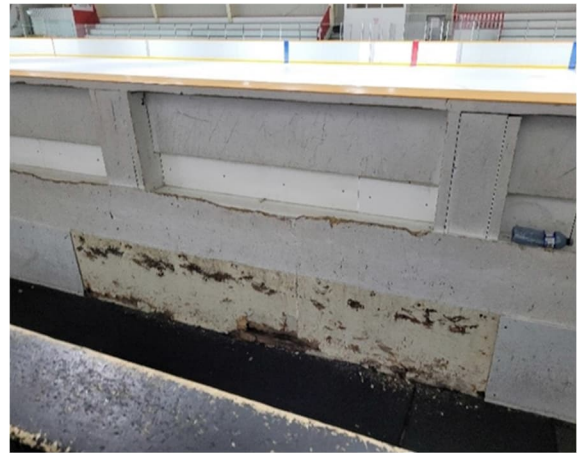
Figure 2-24 Damage to Rink Board in Players Bench Area

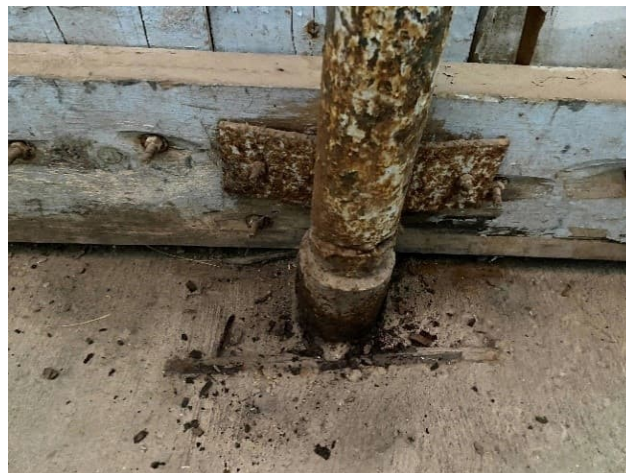
Figure 2-25 Rusting on Metal Support for Dasher Board

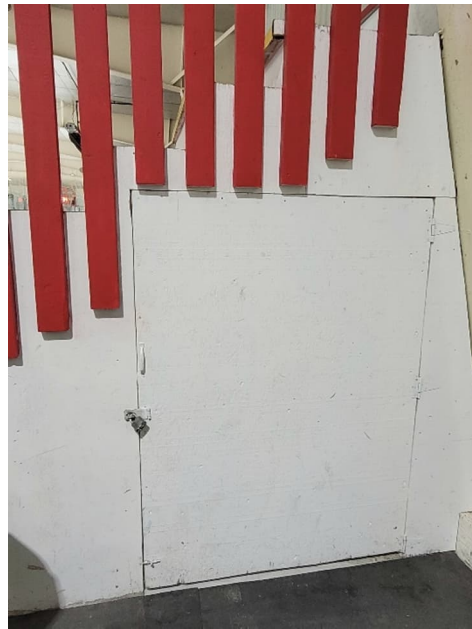
Figure 2-29 Access Gate to Storage Under Bleachers

Since the rink surface and boards need to be replaced and the rink expanded, this will require major modifications to the bleachers. It is recommended to replace the bleachers on the east side, while the west side be either eliminated completely or reduced to accommodate the increased rink area footprint.

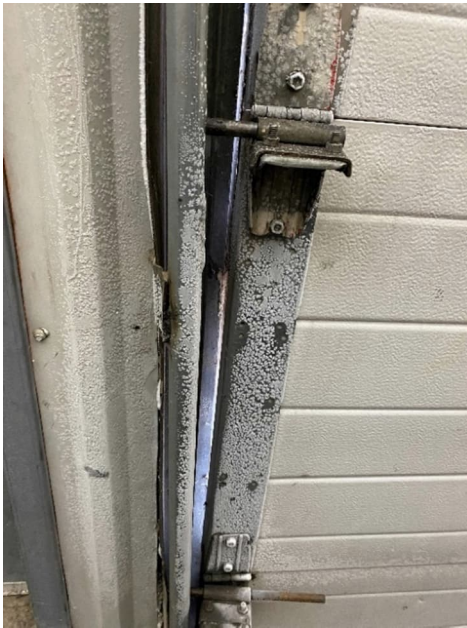
Figure 2-30 Frosting on Overhead Door

It is recommended to replace the existing seals on all doors, add steps to doors that are too high or, when renovating the space, revise the elevation of the floor slab allowing the doors to be closer to the floor level and replace the exterior doors and relocate the overhead door.

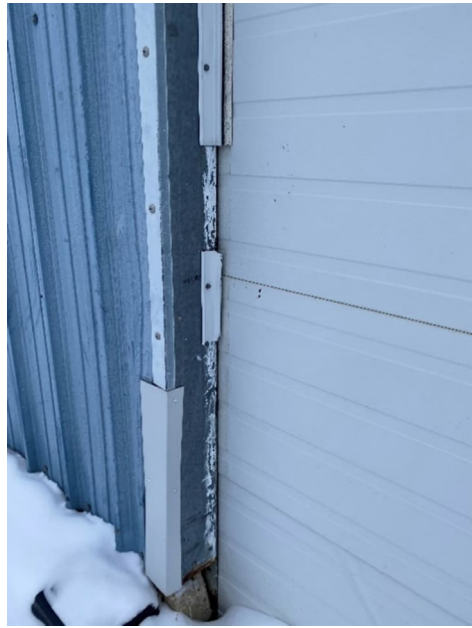
Figure 2-31 Damaged Seals on Overhead Door

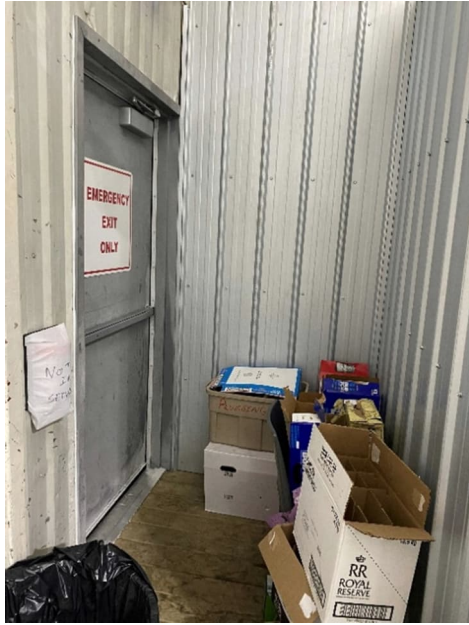
Figure 2-32 Boxes Piled in Front of Exit Path

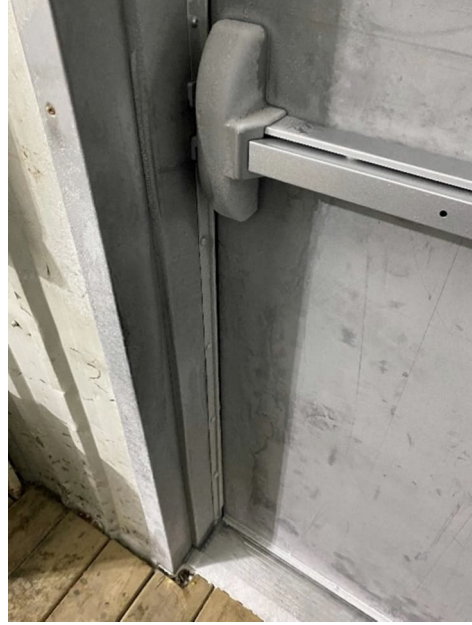
Figure 2-33 Frost Build-Up on Door Frame

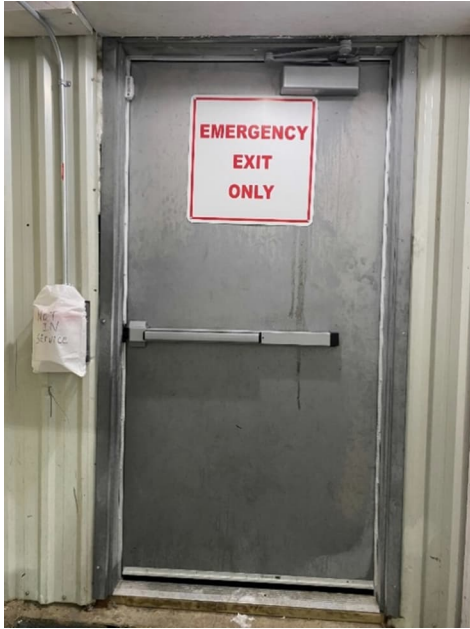
Figure 2-36 Frosting on Exit Door

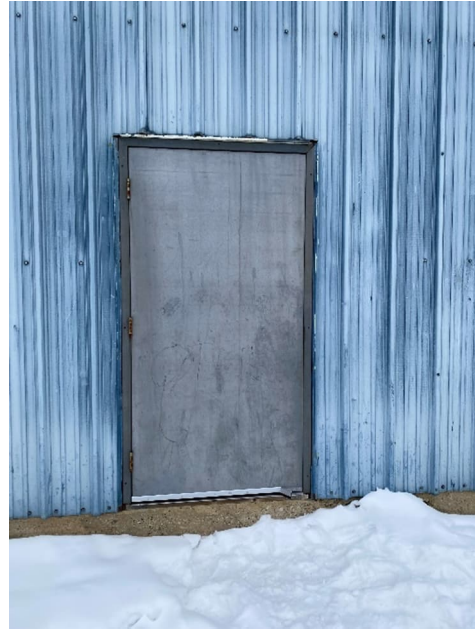
Figure 2-37 Unpainted Exit Door & Threshold Damaged

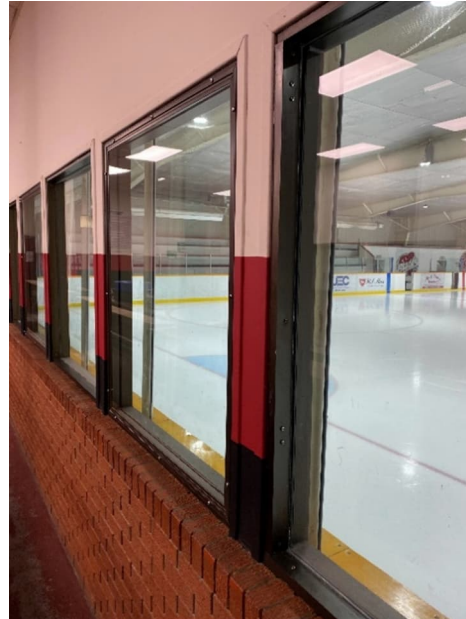
Figure 2-38 Windows Are Not Code Compliant

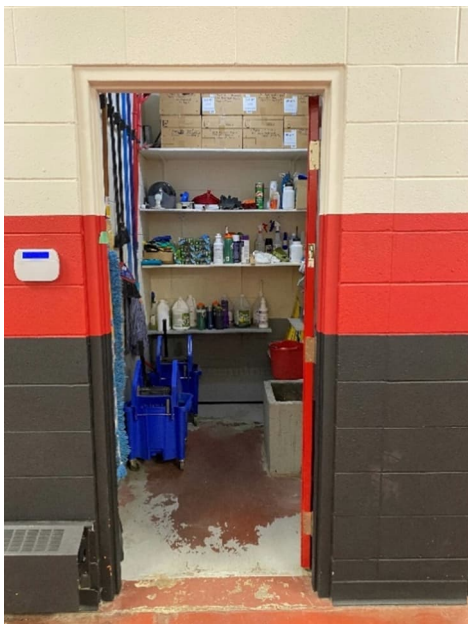
Figure 2-41 Epoxy Flooring Damaged

- Repair wall between the rink and the lobby area to meet the required code requirements.
- Replace damaged interior doors between the rink and the lobby area.
- Replace skate flooring in dressing rooms 1-5.
- Remove and repair epoxy flooring in lobby, janitors, mechanical, storage, and office.
- Replace existing concession and washroom flooring.
- Replace all the millwork in the concession area.
- Patch original concession door with rated wall.
- Replace the vapour barrier and fibreglass insulation above the lobby. Ensure proper tie-in to the existing ceilings and exterior walls.

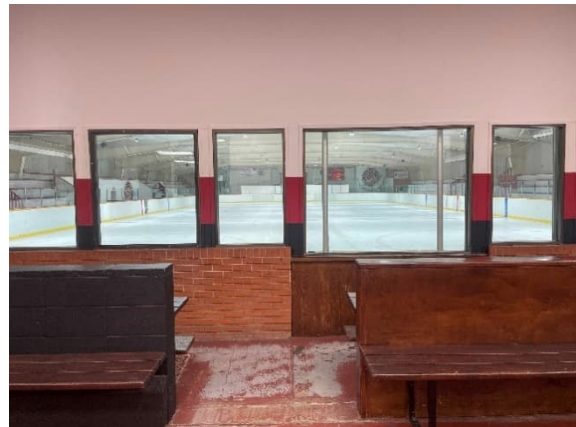
Figure 2-42 Damaged Epoxy Flooring

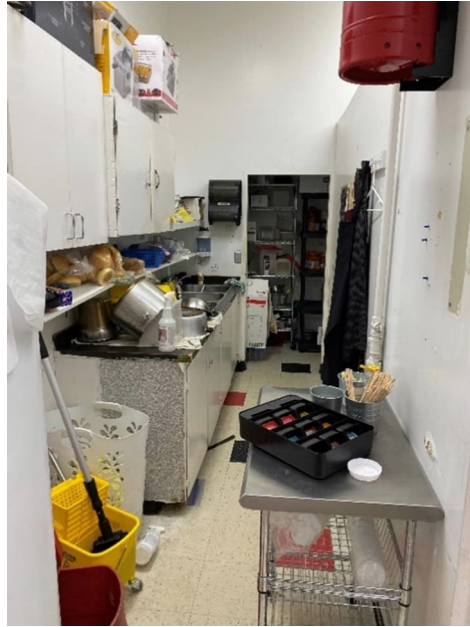
Figure 2-46 Cracked P.Lam Counters & Old Cabinets

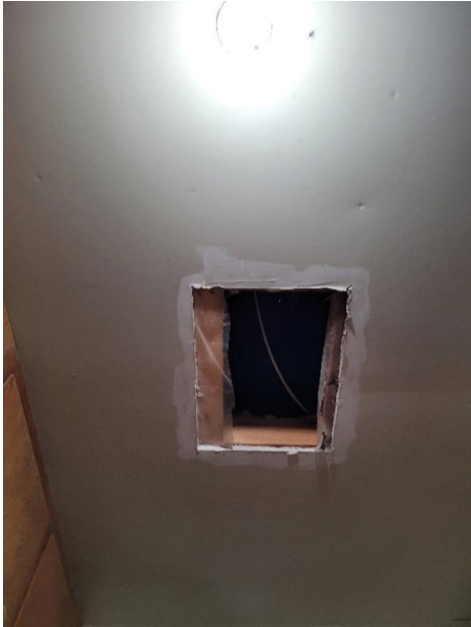
Figure 2-47 Hole in Ceiling Storage Room

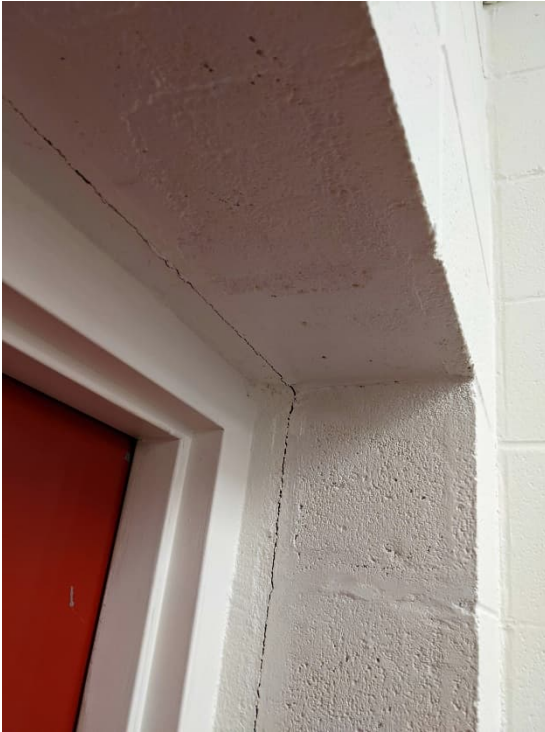
Figure 3-6 Cracking of up to 1.5 mm in Size at Curling Rink Walkway Access Door

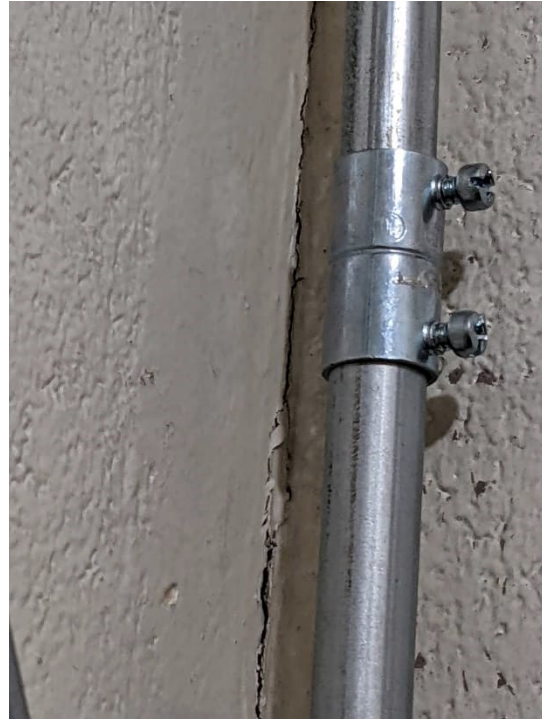
Figure 3-7 Cracking of 0.60 mm in Janitor Closet

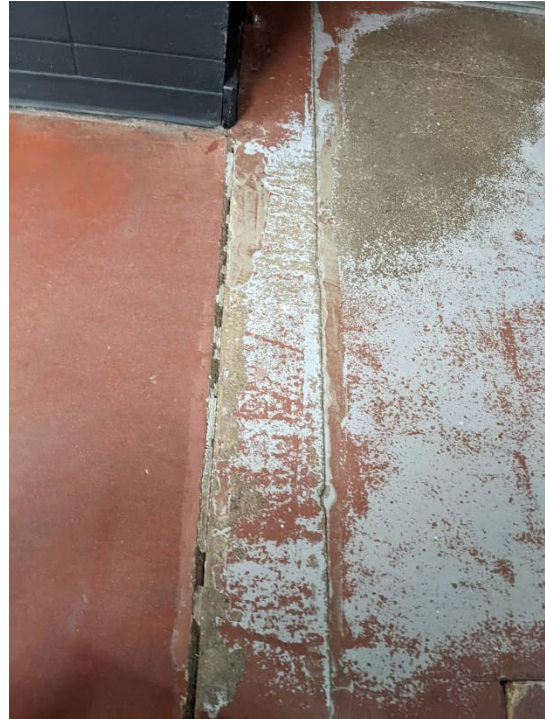
Figure 3-9 Debonding of Bond Break at Beam Line Between Rink and Lobby

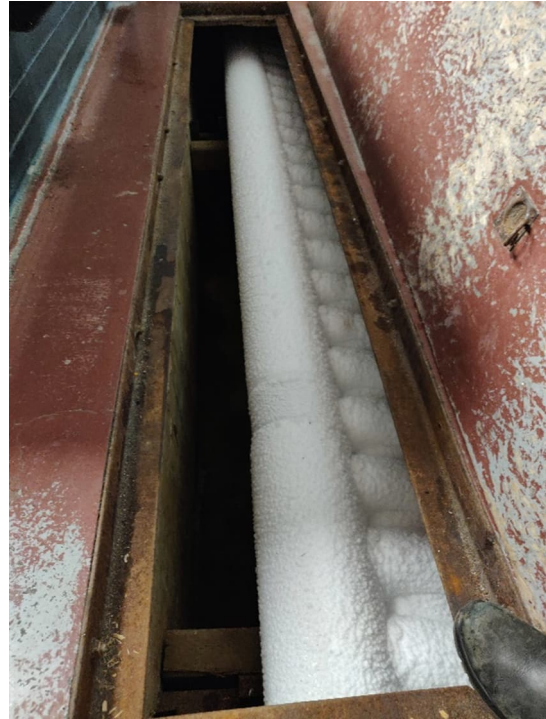
The sump pits and header trench for the rink brine system were also reviewed from within the front lobby. Where visible, the general condition of the concrete is showing mild discoloration and only minor cracking. The trench cover shelf angles and their hardware are showing signs of corrosion and discoloration.

Figure 3-11 Header Trench Shelf Angle Corrosion

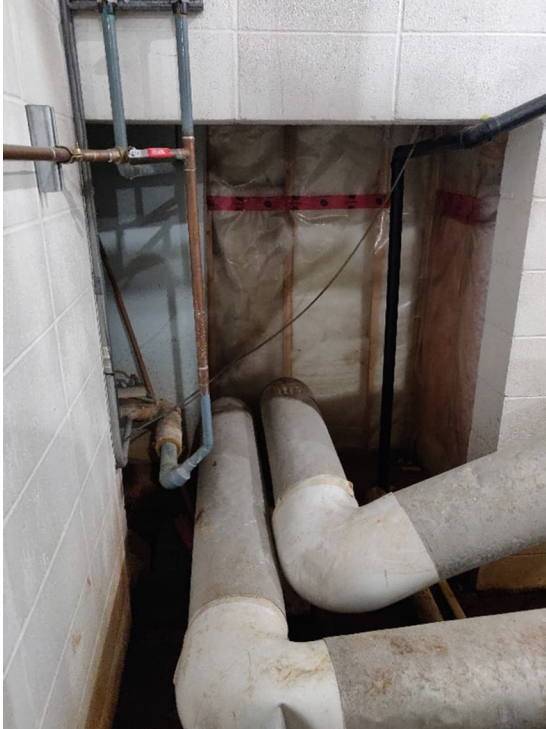
Figure 3-18 Masonry Opening in Southwest Corner of Ice Plant

- Reinforce and provide lintel support for the opening in the southwest corner of the ice plant near the steel pre-engineered column where masonry support is irregular, provide vapour barrier.
- Where the pre-engineered column is experiencing major corrosion, provide waterproofing membrane to isolate this portion of the wall.
- Repair and reinstate the transitions between the old concrete slabs/curbs and the new 200 mm wide by 100 mm tall curbs in the Zamboni Room.
- Miscellaneous concrete repairs to curbs, slab and pits in the Zamboni Room and ice plant.
- Wire brush clean and repaint ice plant pipe supports and skid.
- Clean and re-apply top finish on worn slab surface in ice plant.
- Wire brush clean and repaint Zamboni Room gratings and supports.

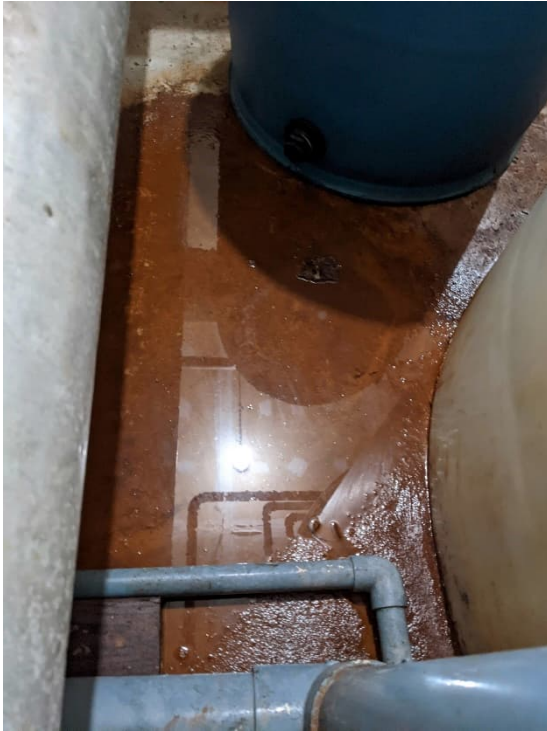
Figure 3-22 Ponding of Water Near Brine Tank in Ice Plant

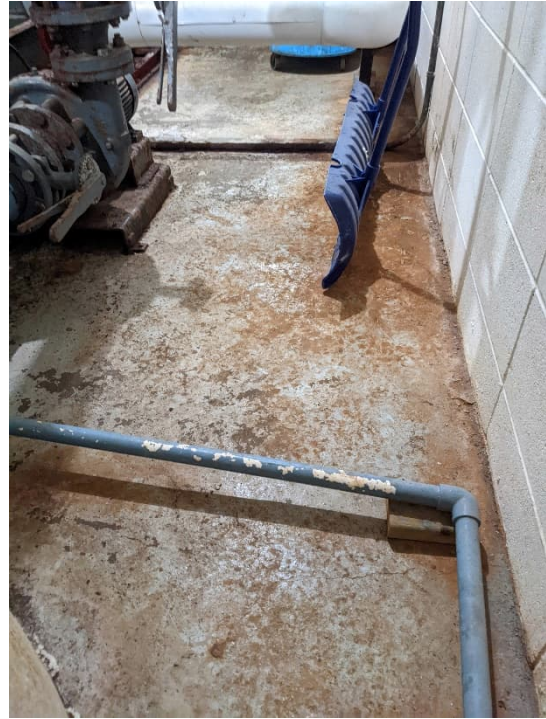
Figure 3-23 Staining and Scaling of Ice Plant Base Slab

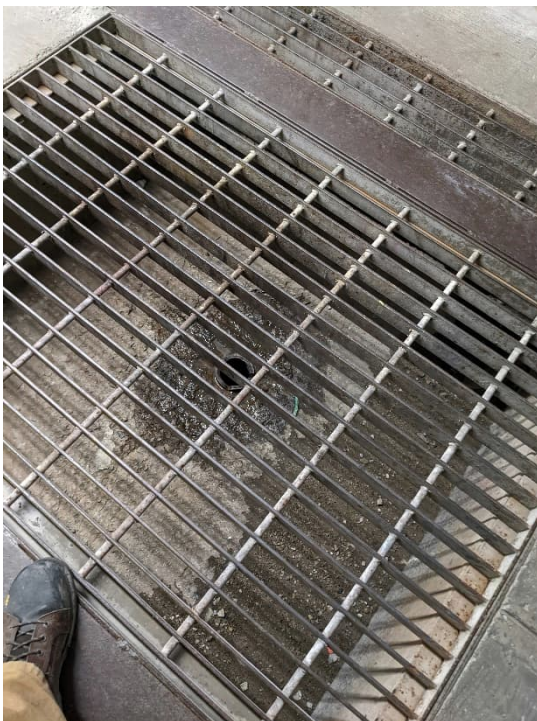
The west drainage pit concrete is in poor condition with the base slab beginning to erode around the drainpipe. This creates a lip around the floor drain, which only intensifies the concrete erosion effects of standing water. The east pit is showing some signs of discoloration and the grating supports are in relatively good condition, however some steel grating sections are showing signs of corrosion. The base of the pit is wet and dirty with extensive discoloration. And some initial signs of concrete deterioration.

Figure 3-26 Extreme Concrete Degradation in Zamboni Room West Pit

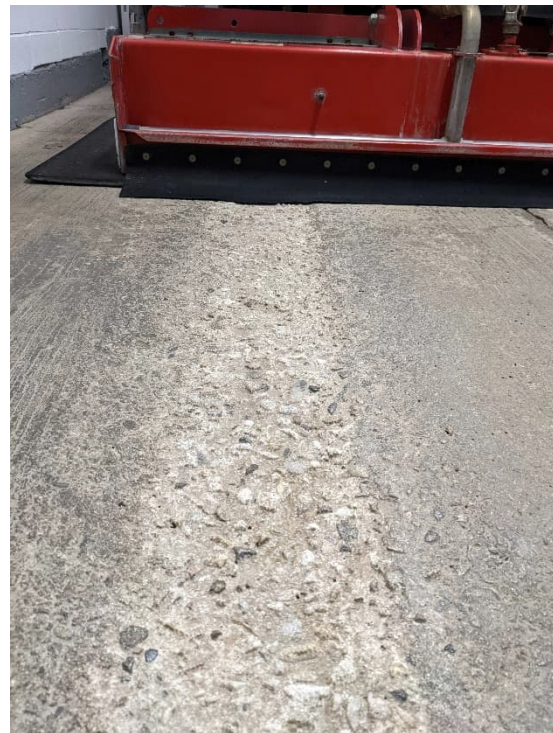
The Zamboni room floor is showing signs of wear, visible discoloration and deterioration and cracking up to 1.5 mm in size. The ice resurfer wheels are beginning to wear the concrete surface where repeated use has exposed the concrete aggregate. Not addressing this will cause further deterioration that can eventually erode the concrete cover and expose the steel reinforcing, causing further corrosion of the slab steel.

Figure 3-27 General Slab Wear from Ice Resurfacer Traffic

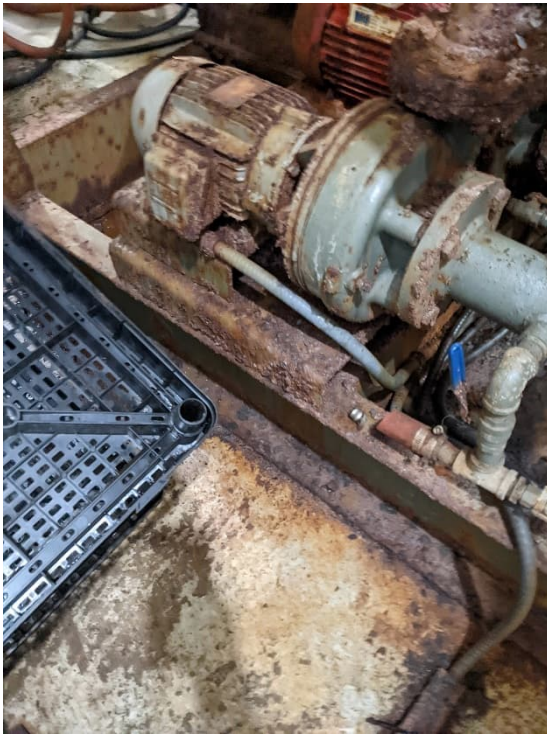
The steel chiller skid in the ice plant is in generally good condition. However, the condition of all equipment supports are deteriorating significantly and showing signs of extensive corrosion near the brine tank. The condition of the equipment and their supports deteriorates considerably and correlates with proximity of the brine tank.

Figure 3-28 Corrosion on Equipment, Supports and Skid

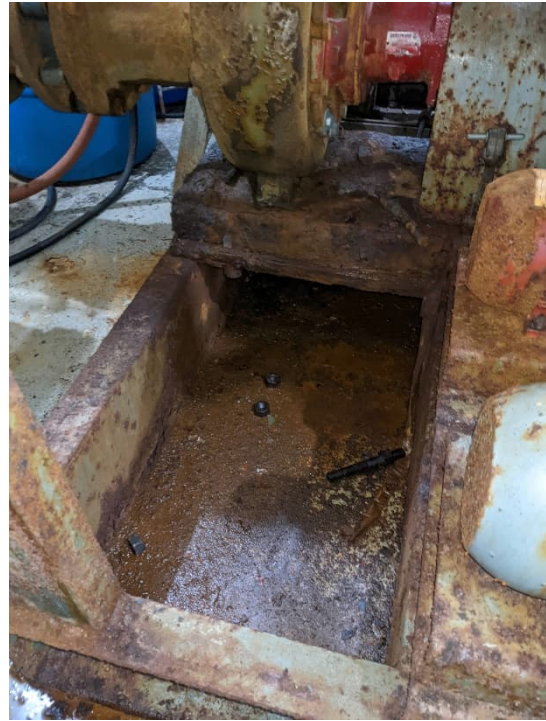
Figure 3-29 Corrosion on Equipment, Supports and Skid

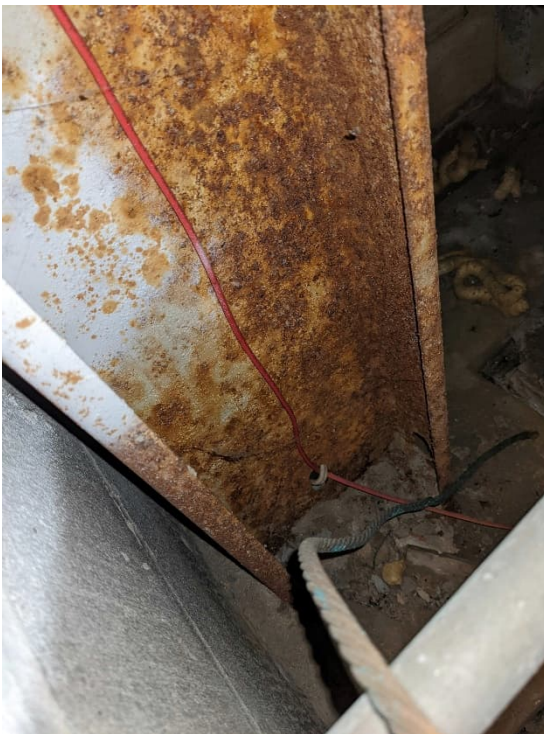
Figure 3-42 Corroding Pre-Engineered Steel Column Near Brine Tank

- Repair and or replace the pre-engineered framing column segment nearest to the ice plant where the brine tank is causing a major corrosion concern.
- Where anchor bolts are not projecting sufficiently, splicing or cleaning and puddle welding of the anchor bolts to the nuts is required.
- Structural Roof inspection of Main building and east addition.
- Replace the condenser unit steel support frame with galvanized steel framing.
- Repair concrete slab where debonding from wall curb.
- Clean and re-apply top finish on worn slab surface.
- Wire brush clean and repaint pre-engineered steel.

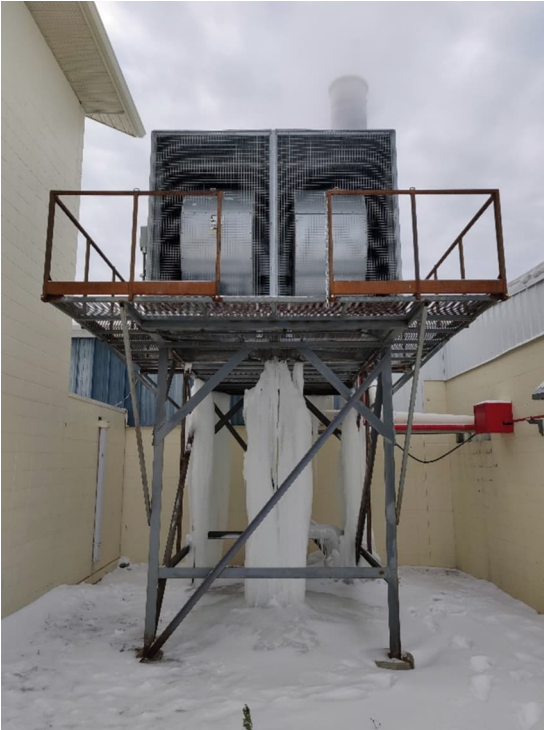
The overall condition of the steel frame varies from element to element, where there is some visible corrosion found on many of the platform elements and some of the diagonal bracing. The bases and their anchorage are showing signs of corrosion where they are beginning to bleed, stain and discolor the tops of the concrete foundation piles. Substantial amounts of frozen water coming from the underside of the unit was visible at the time of the review. This suggests a high-moisture atmosphere for some of the frame elements and there was no indication of any of the steel elements having been galvanized. Only a standard primer finish was provided to this framing, no galvanizing.

Figure 3-46 Exterior Condensing Unit Steel Frame

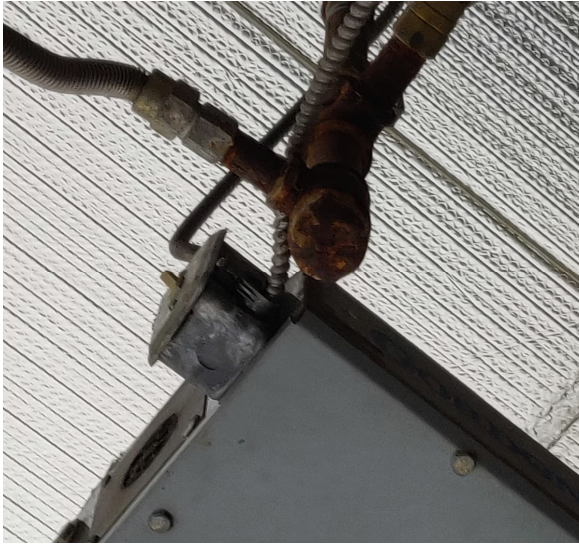
Figure 4-26 Typical Corroded Gas Pipe Fitting in Arena

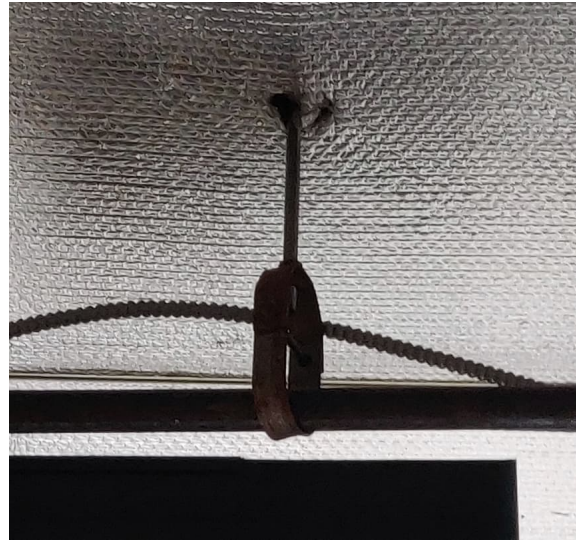
Figure 4-27 Typical Corroded Gas Pipe Hanger in Arena

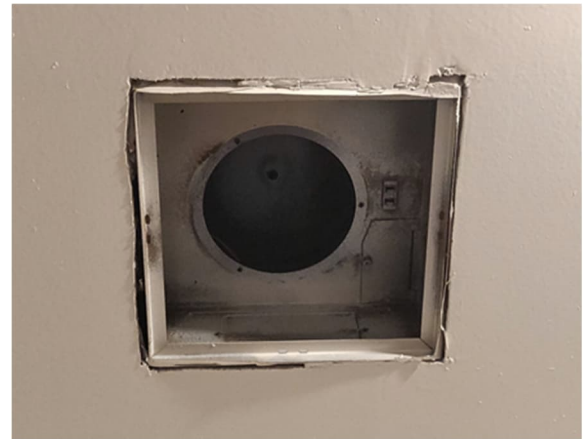
Figure 4-39 Typical Cabinet Exhaust Fan Missing Grille

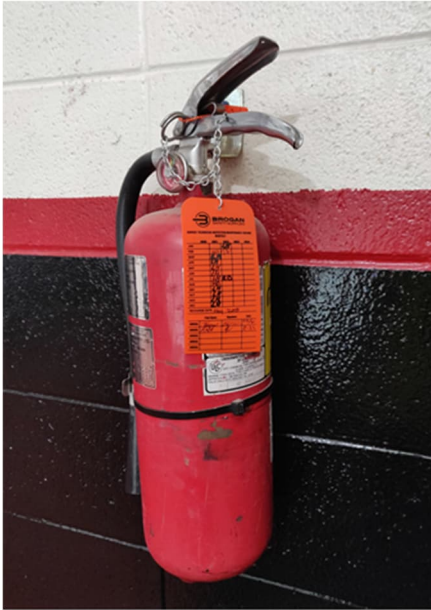
Figure 4-49 ABC Fire Extinguisher in Arena with Chipped Paint
