ROOF ASSESSMENT SURVEY REPORT
BEAVERLODGE POOL
91016 – 4TH AVE, BEAVERLODGE, AB

ROOF ASSESSMENT SURVEY REPORT – BEAVERLODGE POOL

Topside Consulting (2004) Ltd. has been retained to provide a Roof Assessment Report to ascertain the condition of the various roof systems on the five different areas, and give the owner a timeline for, and understanding of, the need for repairs and replacement. The building was inspected on May 4th, 2026.

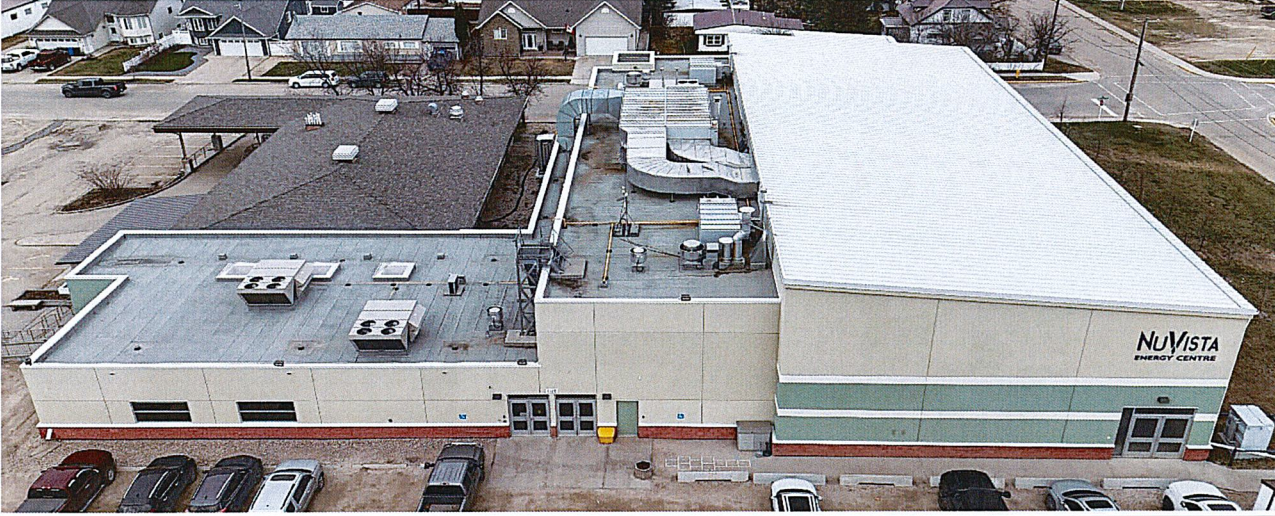
.1

An aerial view of the flat SBS membrane roof areas and the large metal roof over the pool itself. Note the large size and number of units on the upper level flat roof.

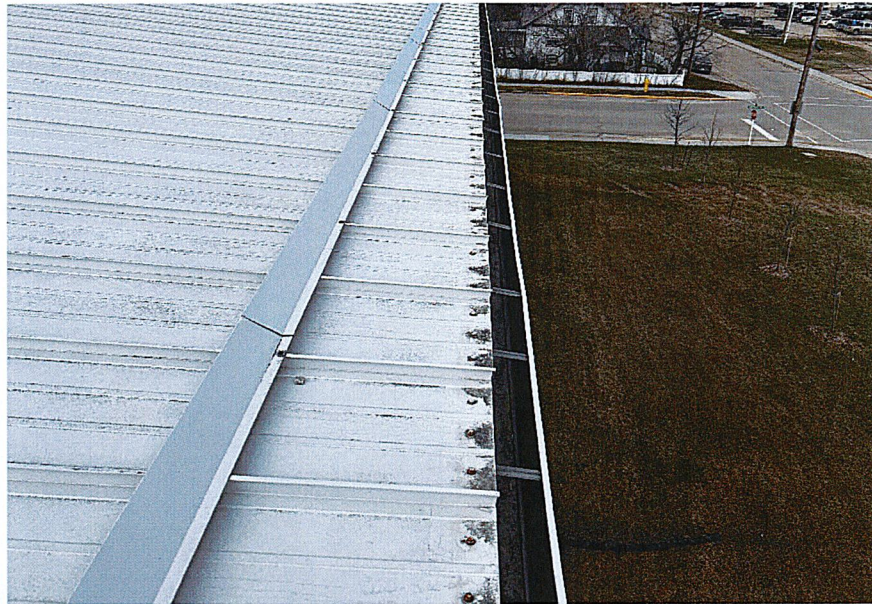
.2

The metal roof eaves have a snow stop about one foot up from the eaves which appears to be working well. R1
This is a standing seam roof with 1.5" high ribs - 16" oc.

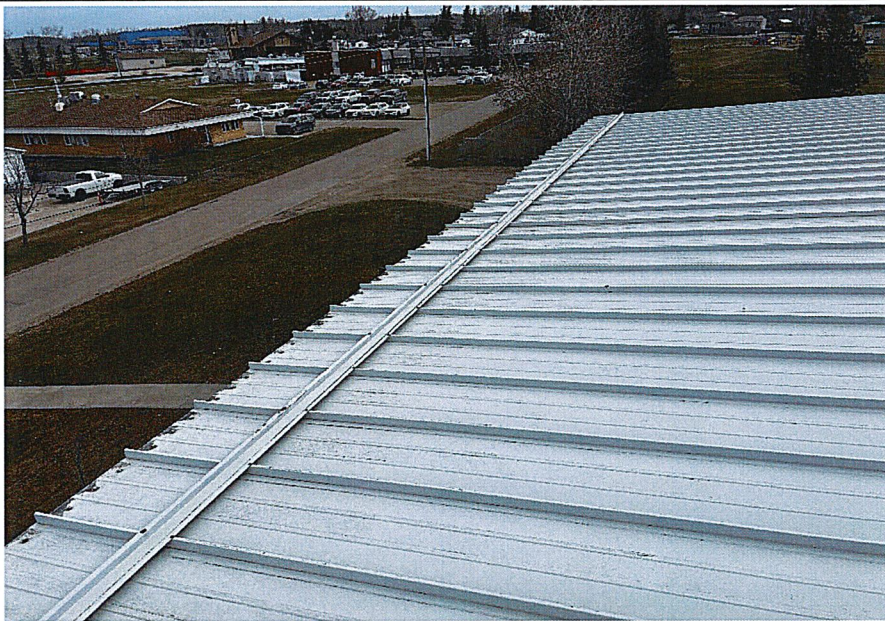
.3

This feature is mounted along the entire eaves length.

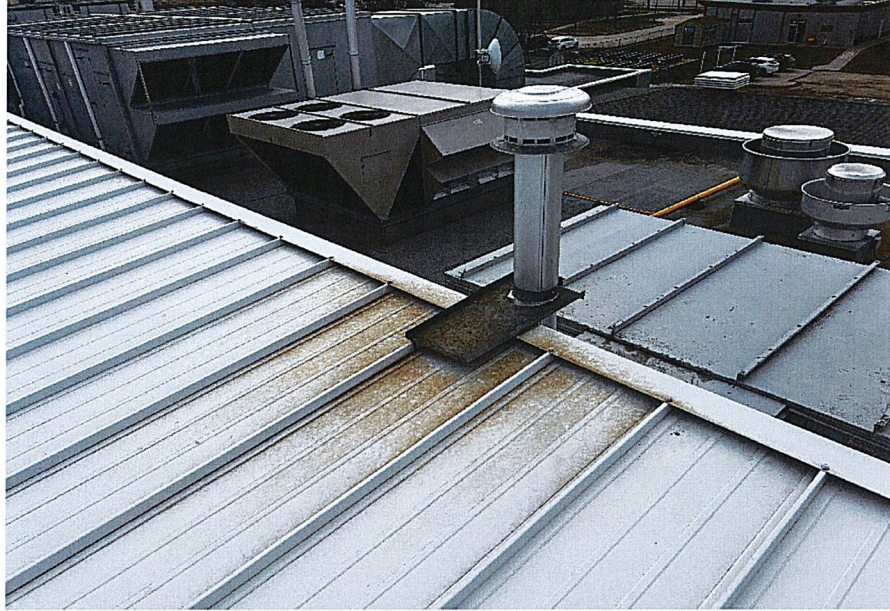
.4

The B-vent stack off one of the units on the lower roof has a wind brace mounted to the high end of the sloped metal roof. There is staining of the glavalume but no deterioration

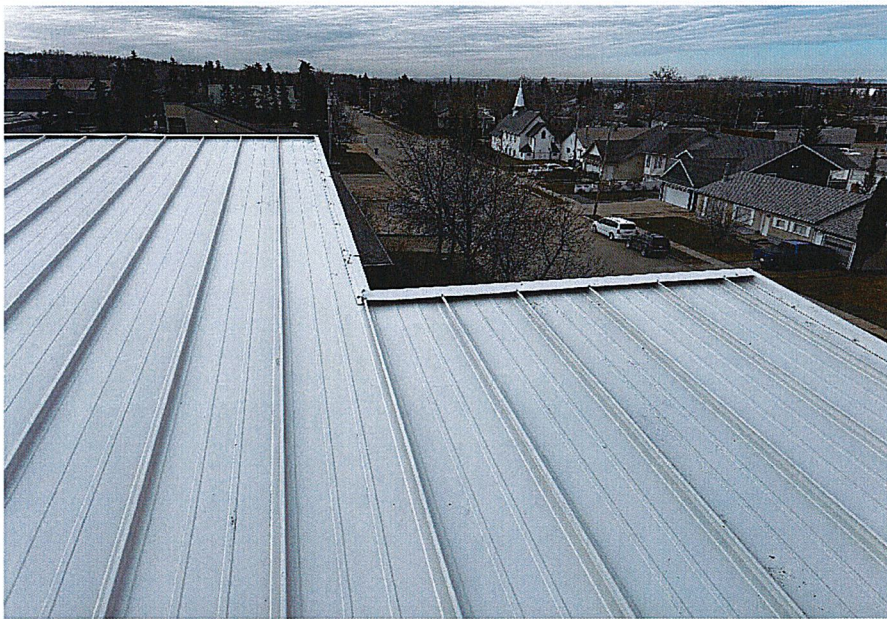
.5

The top edge of the slope has a proper cap flashing over the panel ends - well fastened.

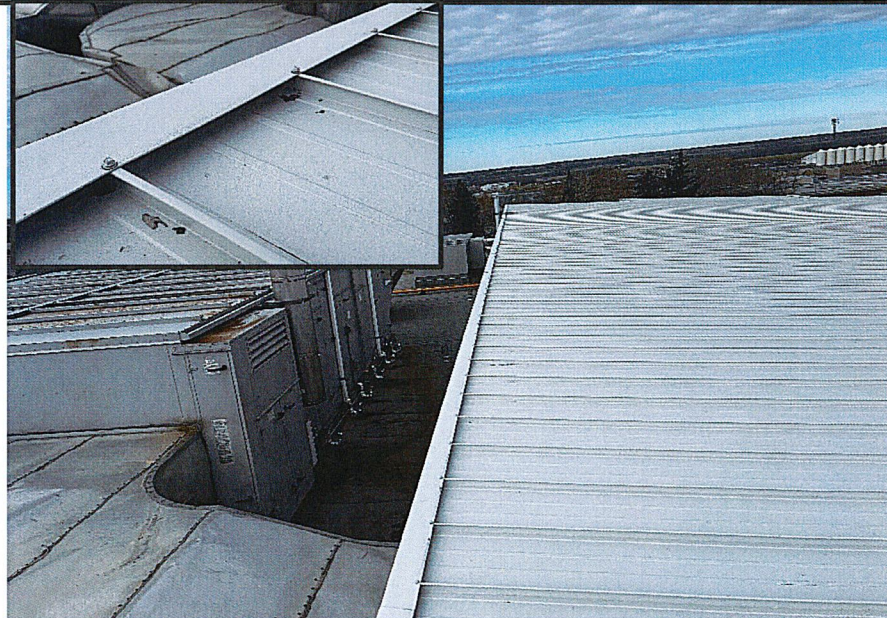
.6

Looking down the peak of the roof the flashing is straight, and a screw on every rib.

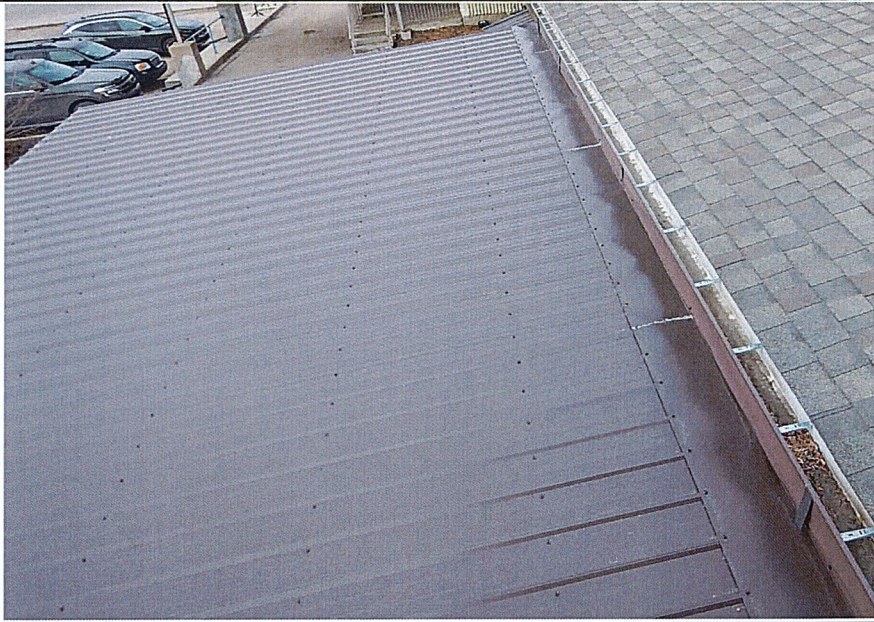
.7

Where the lower flat roof joins the shingle roof, there is a metal roof adjoining the eaves of the shingle roof. R4

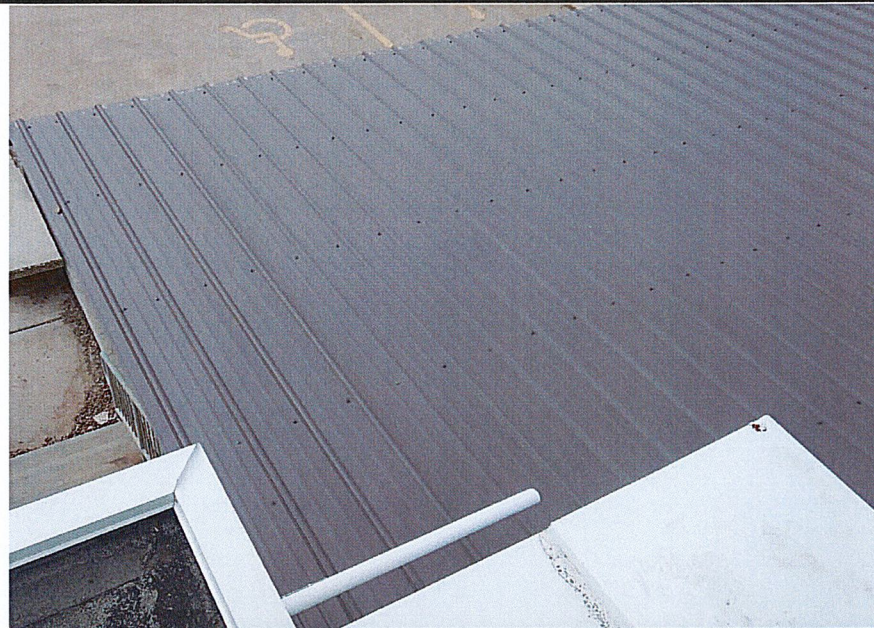
.8

This is an exposed fastener roof with ribs about 8" oc. . The roof has no penetrations, and does not appear to have any issues.

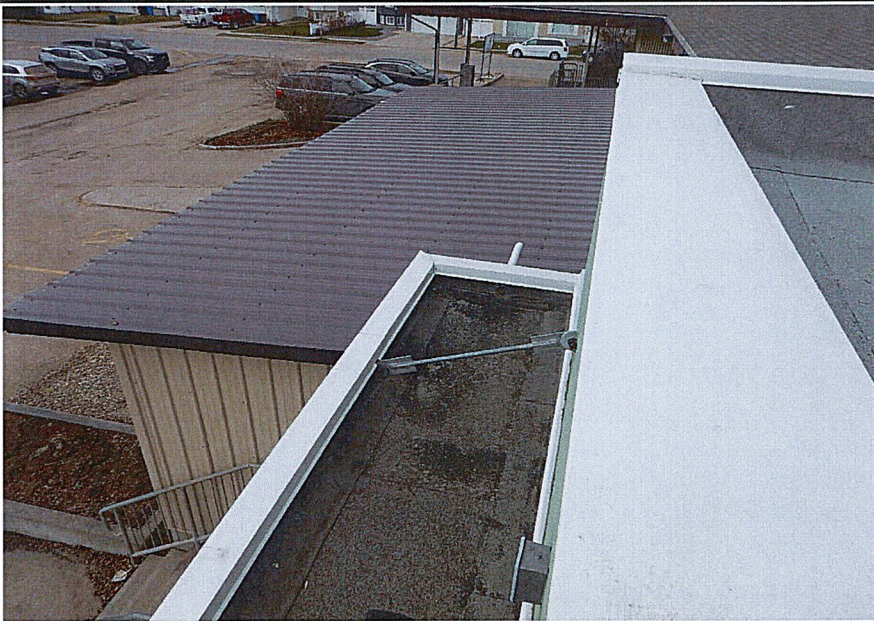
.9

The small entrance canopy roof drains on this metal roof with a small 2" pipe scupper. R3a

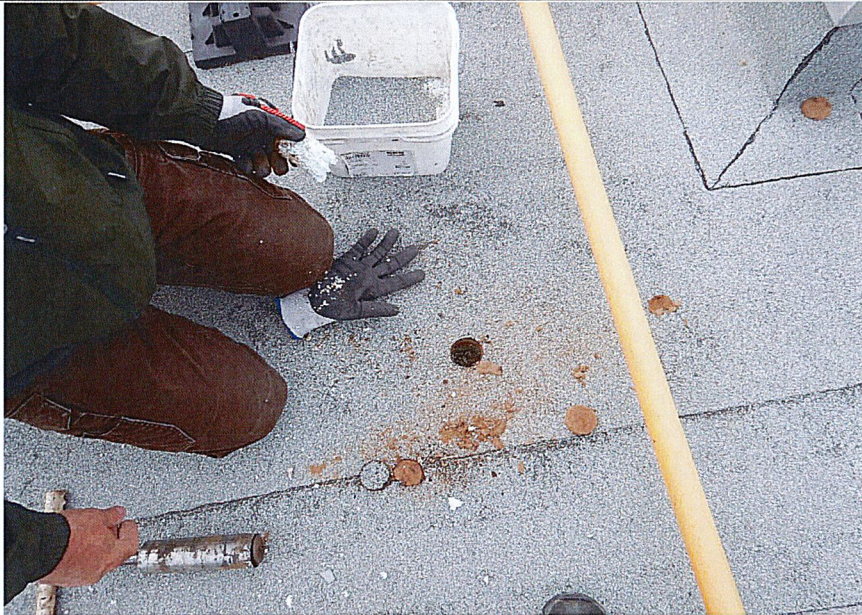
.11

R3-We performed 3 separate cut tests on this roof, all having the same system.

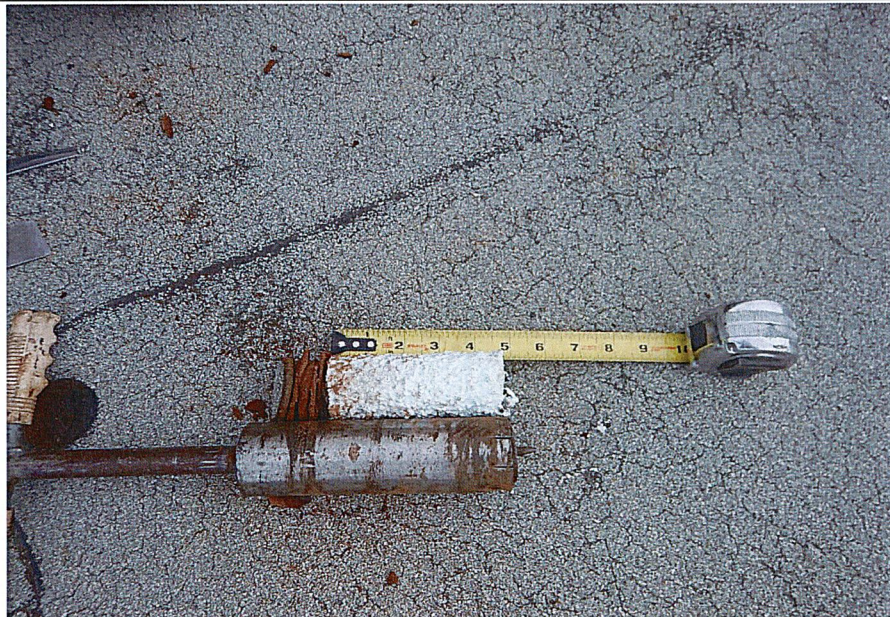
.12

The system as shown here is:

- Steel roof deck
- 1/2" dyrwall
- 2-ply tar & felt vapour barrier
- aprox. 3" to 6" sloped EPS
- 1" fibreboard
- 2- ply SBS torch-on

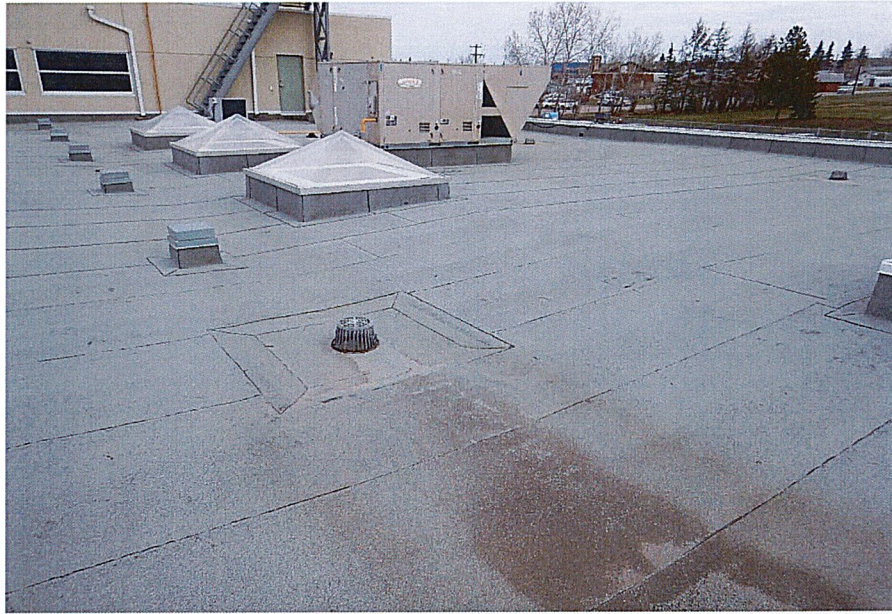
.13

From the southeast corner of the roof - an overview , noting the bit of ponding right in front of the camera.

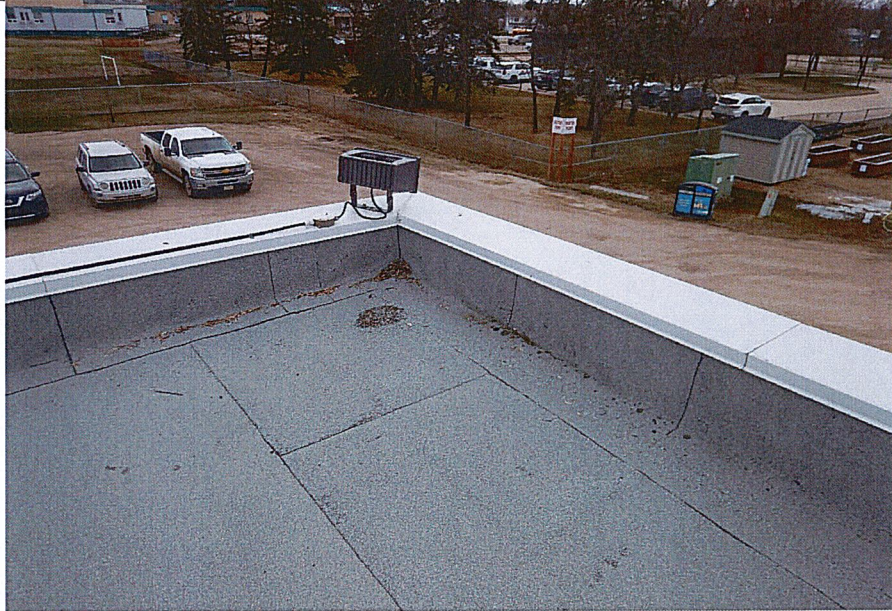
.14

There are a few locations where the membrane is pulled at an angle in the corners with the wrinkles beginning to show.

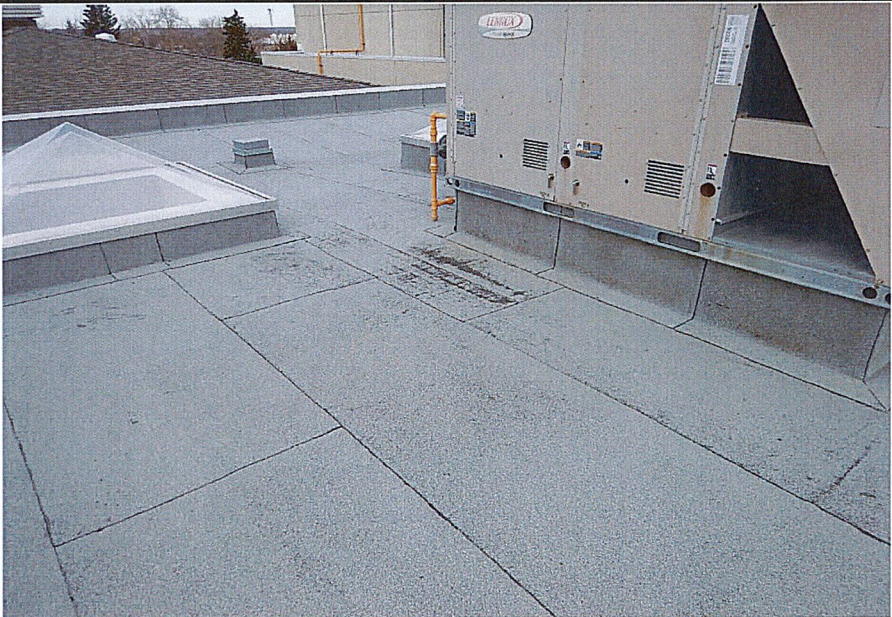
.15

There is evidence of wear around the units, with granule loss in certain spots.

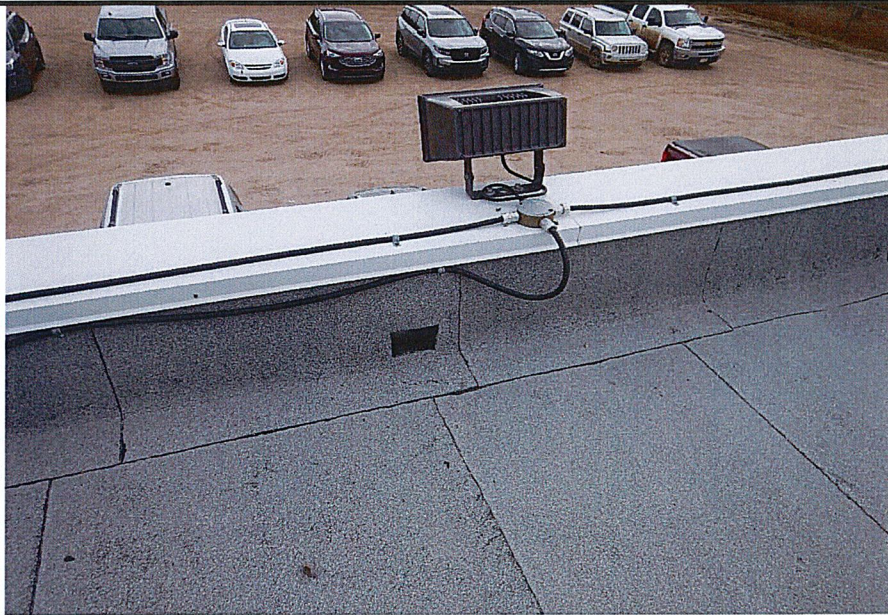
.16

The cap flashing is installed with adequate screws on the inside. The scupper drains appear to be well sealed to the scupper flanges.

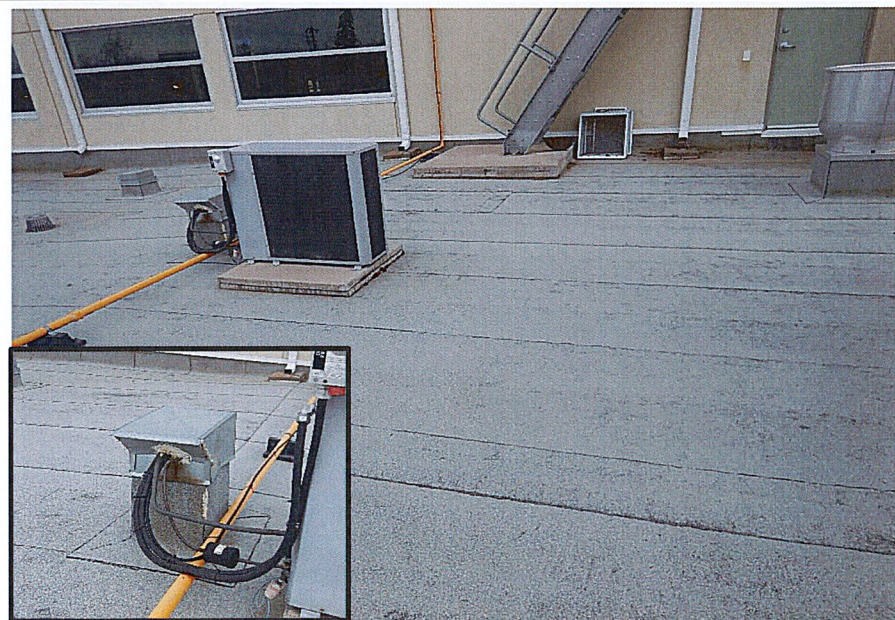
.18

Looking towards the access door we see more granule loss and a cable mini-curb that is properly built and sealed, but might need some maintenance

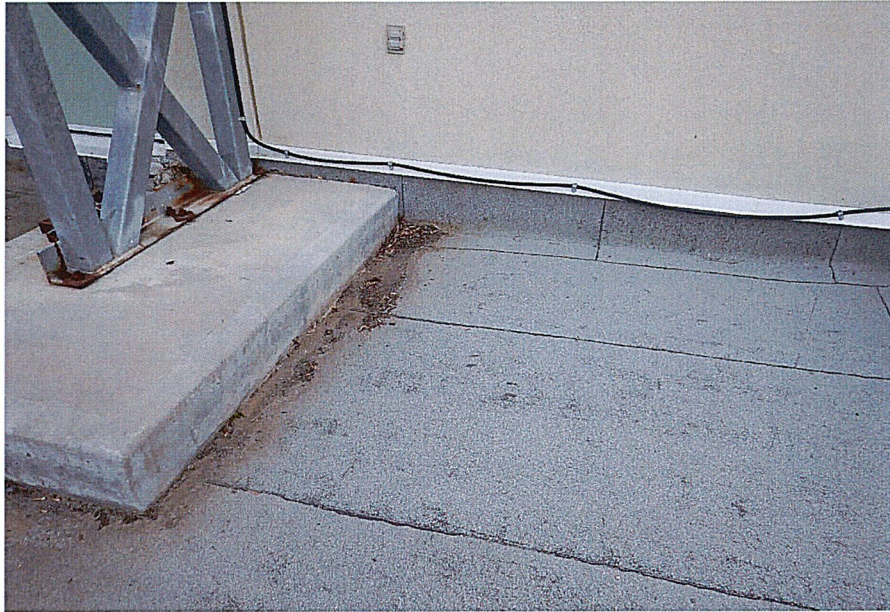
.19

The large and thick concrete pads that the stair posts are anchored on are sitting on top of the insulation of the roof system, as evident in the notable drop in roof line near the pad, and the membrane runs through under the pad. This kind of construction does not meet any code I am aware of, especially when the EPS insulation does not even meet 10 lbs/sq in compressive strength.

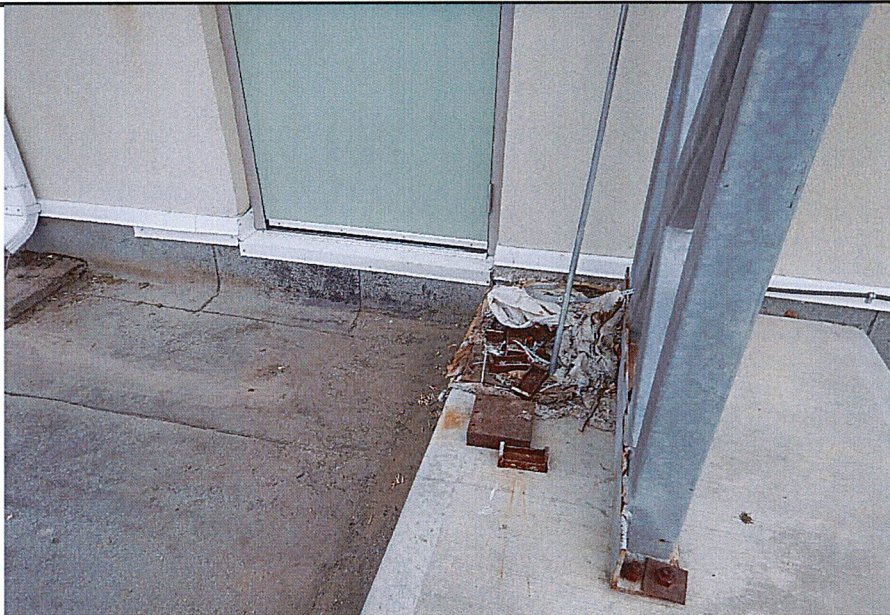
.20

The access door is raised high enough above the roof line, but the membrane directly below and all around is definitely well worn from the boot traffic

2. Install a large cap sheet patch as outlined over the area on R2 east of the large ducts by: cutting out and removing the blistered cap sheet first, fitting base sheet pieces to fill in the missing spots, and then properly covering the whole area with 250 cap.
3. Installing walkway cap sheet in the area in front of the access door and the kick face of the door sill.

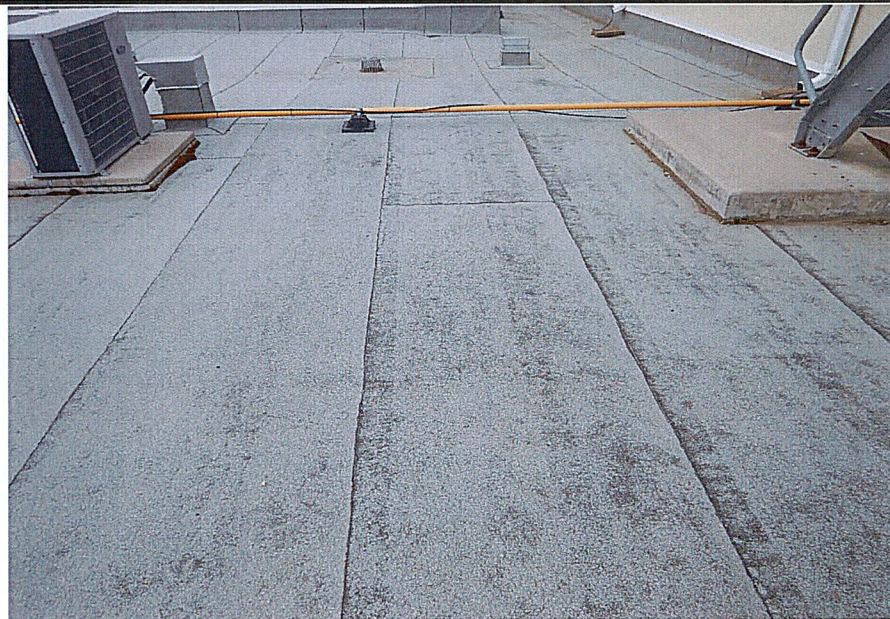
.21

This worn off granule area extends for a ways out from the door onto the field of the roof.

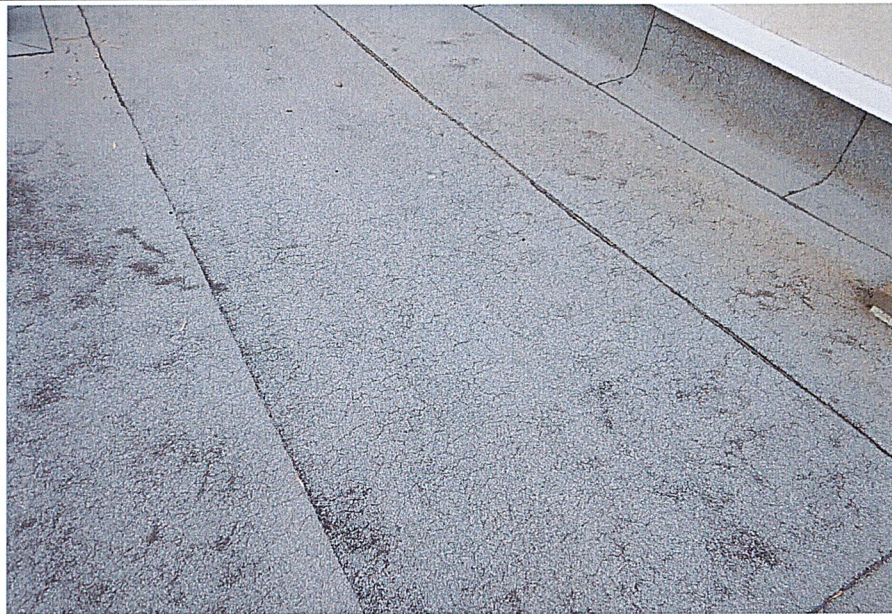
.22

A close look at the roof that catches the reflective heat off the west facing wall and we see the start of "alligatoring" This is when the added heat and time have seen the VOC content drop and the asphalt is now starting to dry out and "alligator". This is not yet severe, more time will see this start to threaten the integrity of the cap sheet.

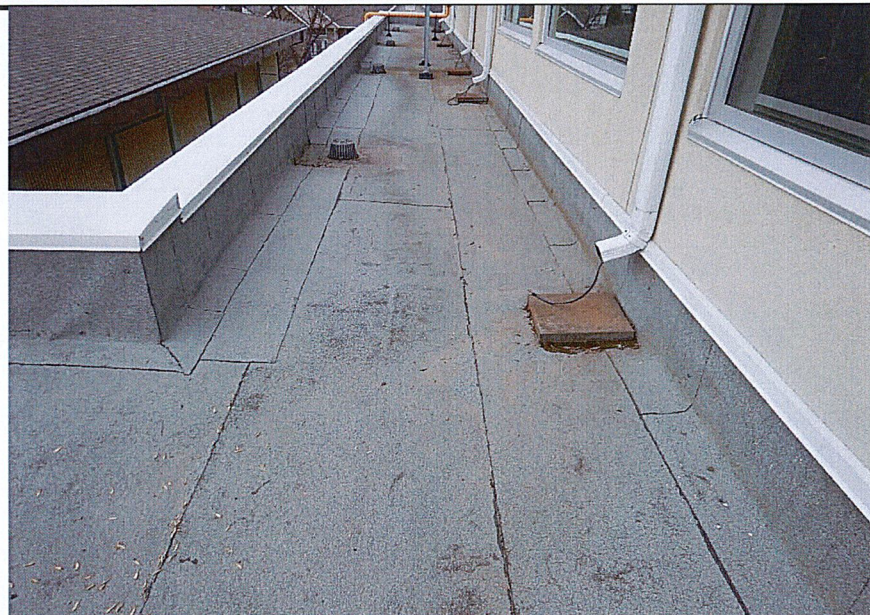
.23

This south arm of the lower roof has more alligator patches all the way down. There are four drains with the sloped EPS getting the water to them.

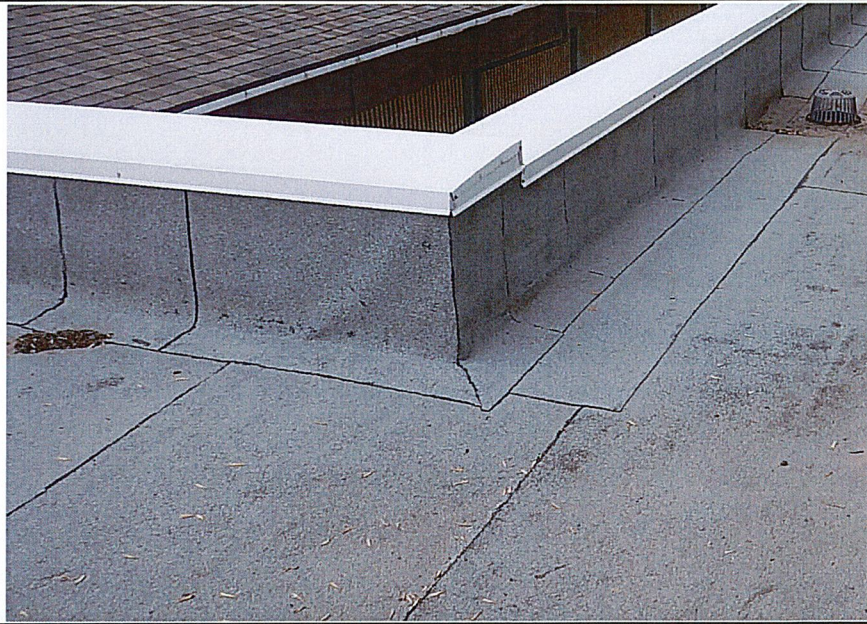
.25

Right beside the camera is a minor angled wrinkle in the parapet wall membrane flashing

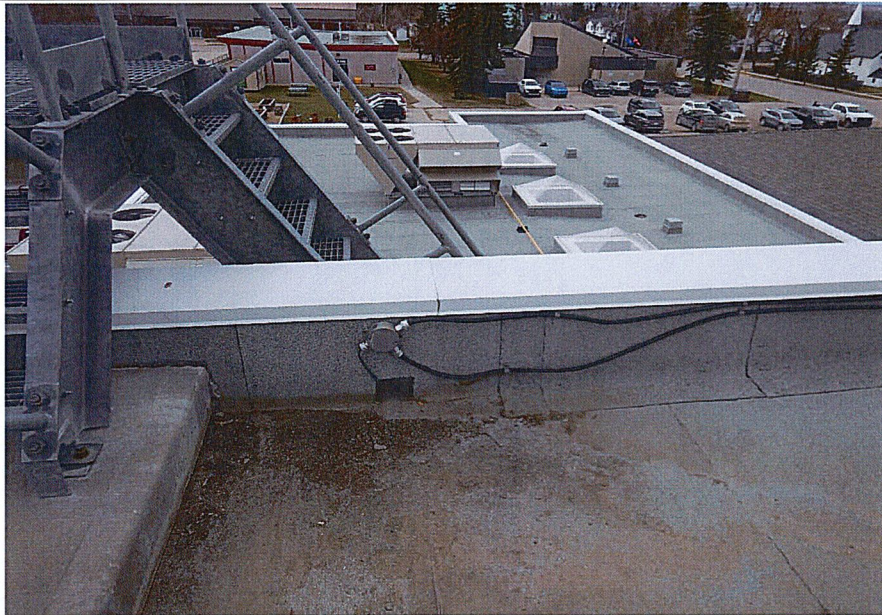
.26

The top of the heavy stairs has another concrete pad that has compressed the roof system under it as the water leaves deposits along side the pad.

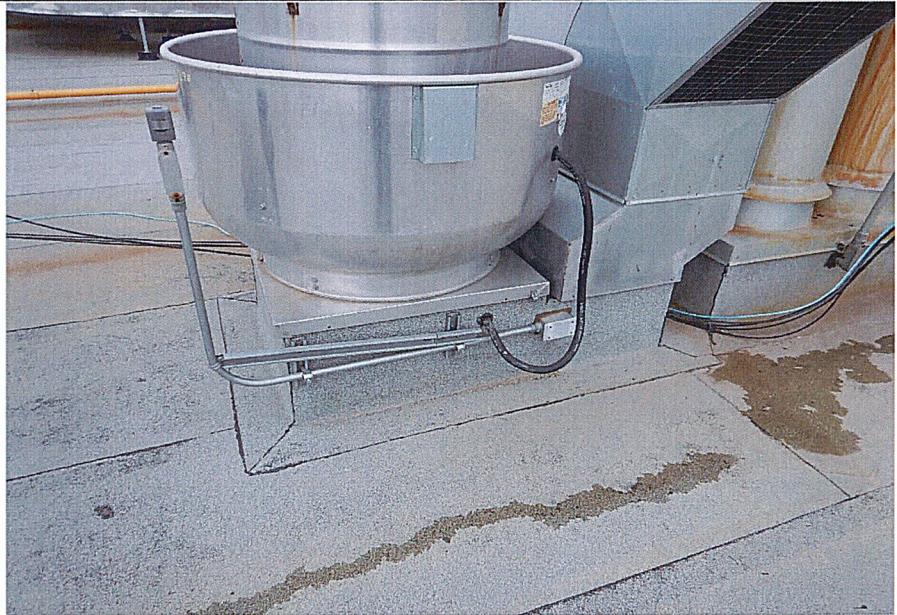
.29

The practice of electricians drilling a hole in the side wall of a curb and punching a cord through with only a bit 'o gum to seal it is well known to have long term problems.

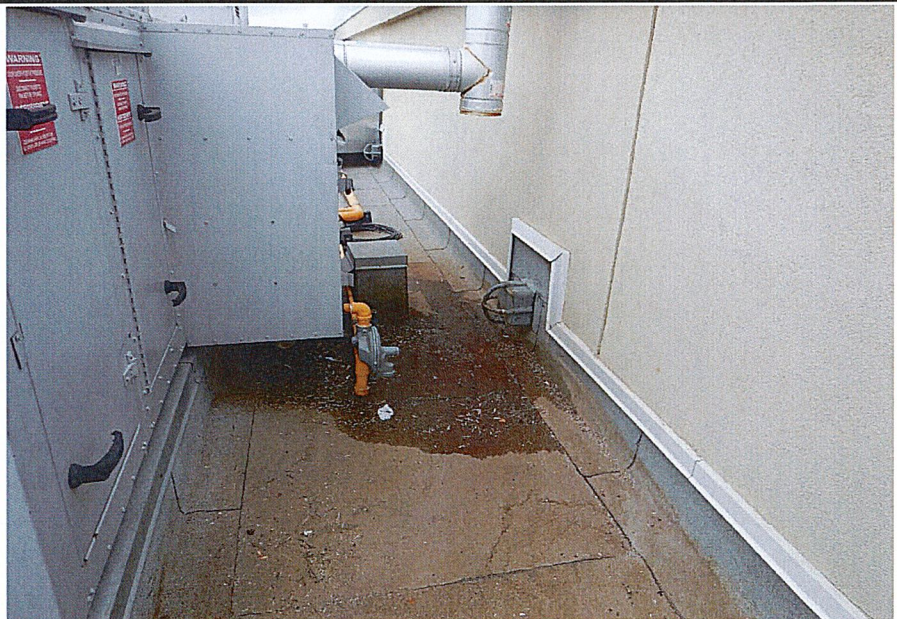
.30

The "safety anchors" on this roof are actually on the wall. There appears to be a lot of water trapped between the wall and the units on this roof as evident in the collection of dirt and debris.

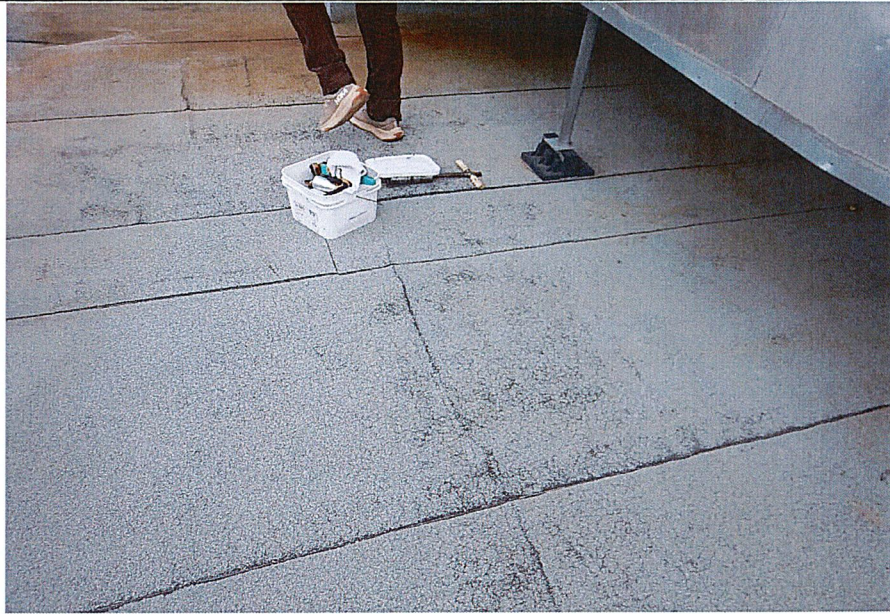
.31

On the west side of the large ductwork off the huge unit, we see numerous ridges and blisters in the area. This one area we plan to do a cut test to find out what is in the roof system.

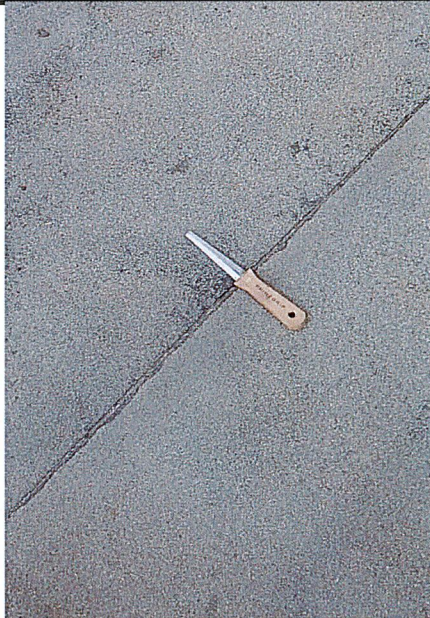
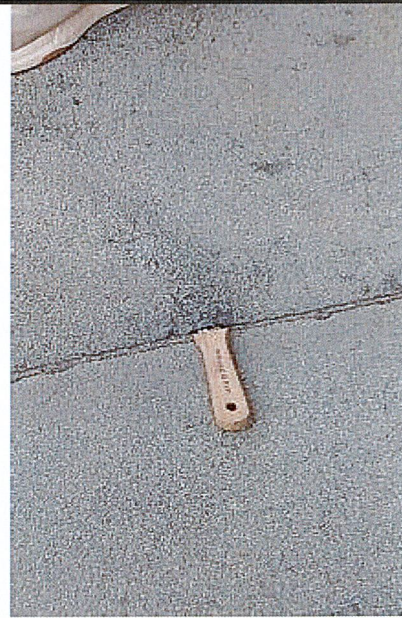
.31

One birdsmouth opening at a buckle line has an opening that is well past the lap seal, and thus onto the base sheet. This type of opening has a risk of becoming an actual leak into the roof system.

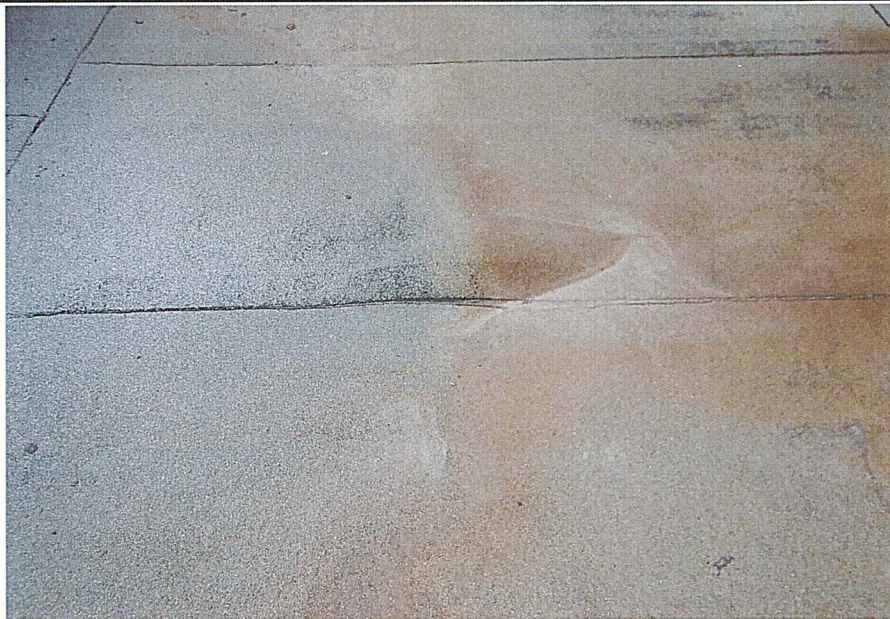
.33

There are several of these blisters/ridges that are found in this area.

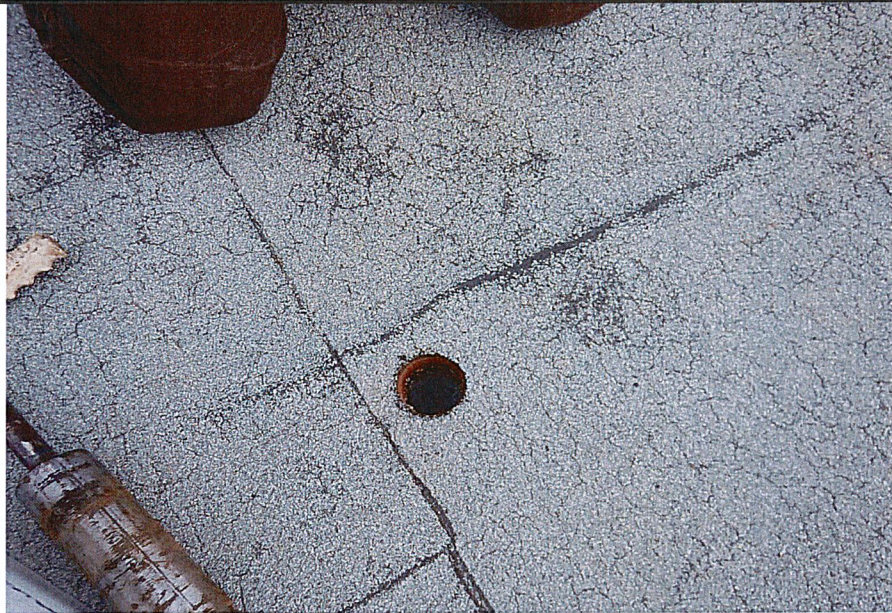
.34

Another cut test in this area shows that the fibreboard at present is dry, but it has definitely been wet at one time.

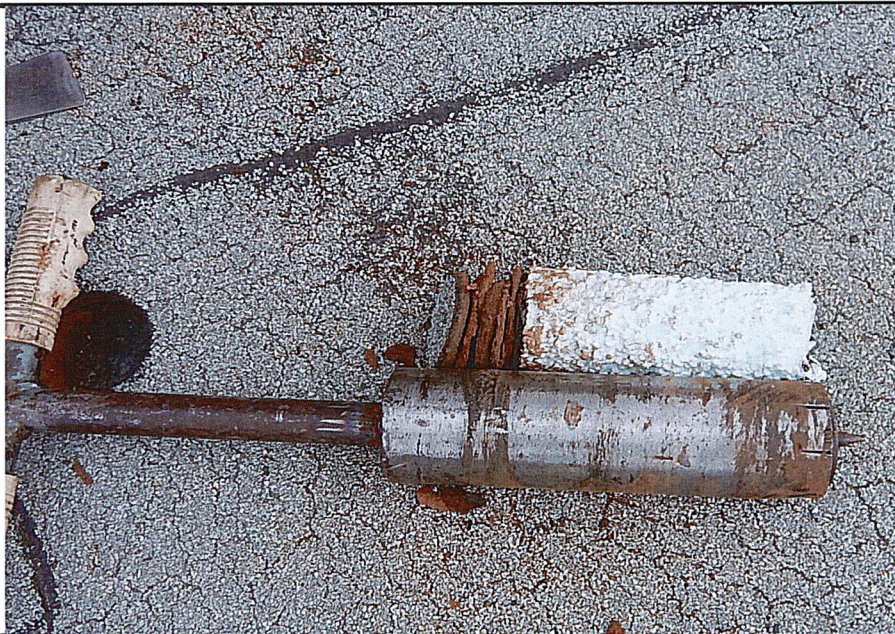
.35

The ease of cutting through it, the fall apart into thin wafers, and the amount of "dust" it has to it, are all indicators of past moisture damage.

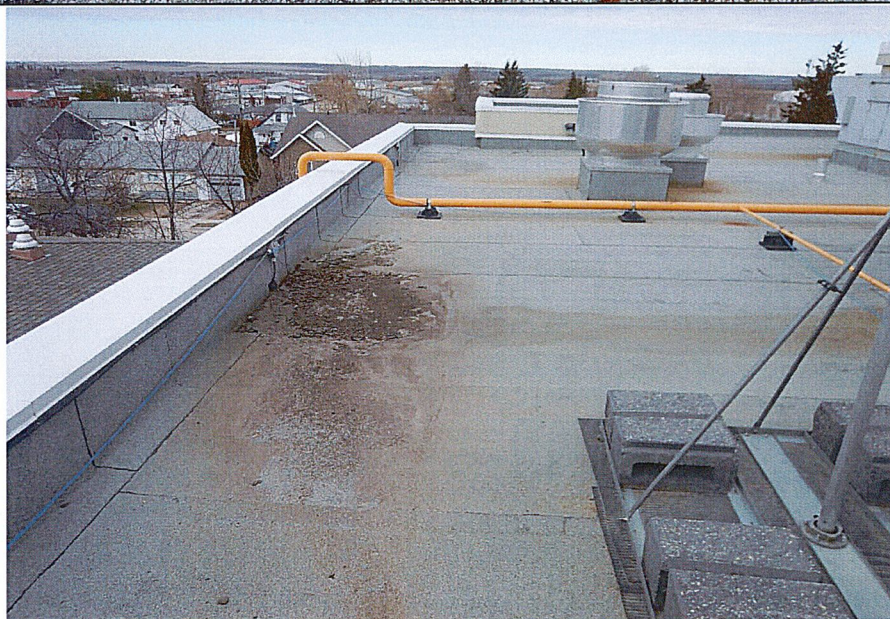
.36

There is some minor ponding near the scupper drains on this roof area, that can be easily addressed when the roof is updated.

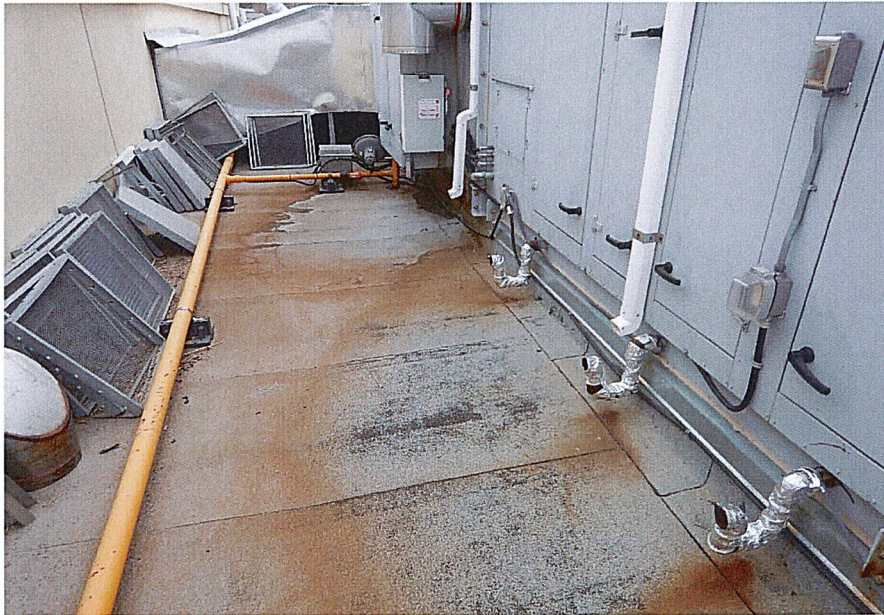
.38

More granular wear, and a lot of "stuff" on the roof. Not the best place to store it.

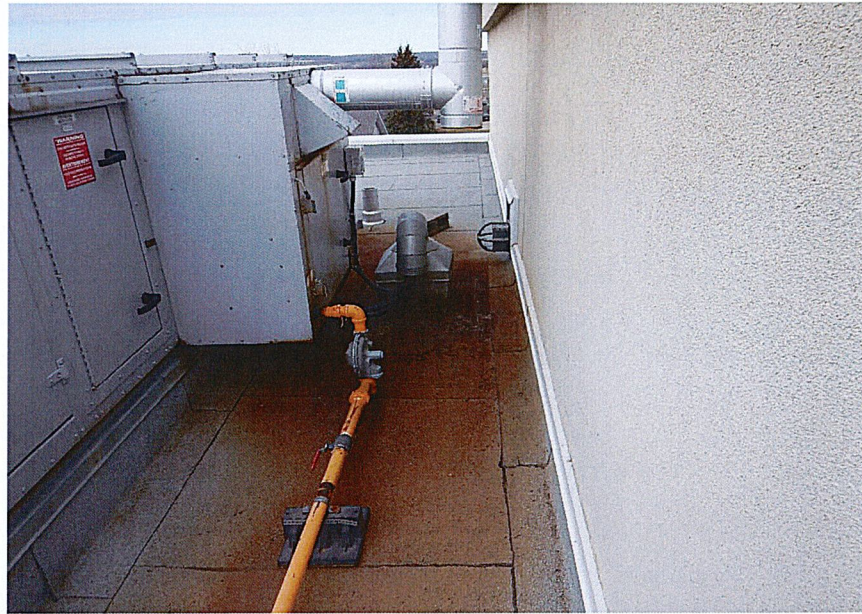
.40

More evidence of water trapped behind the units. The cables exiting out of a gooseneck pipe is a better way to keep their exit sealed.

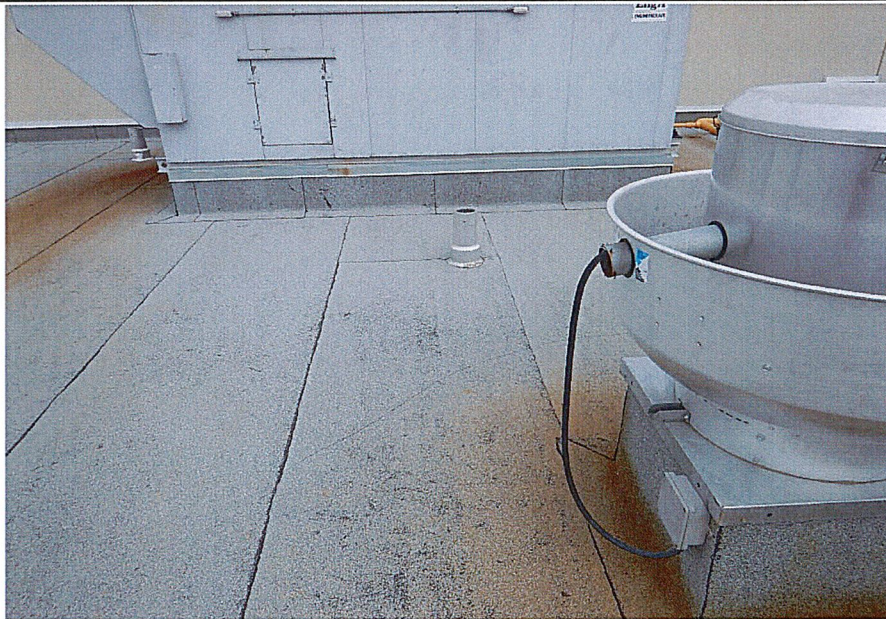
.42

Another method of sealing the cable entrance into the curb.

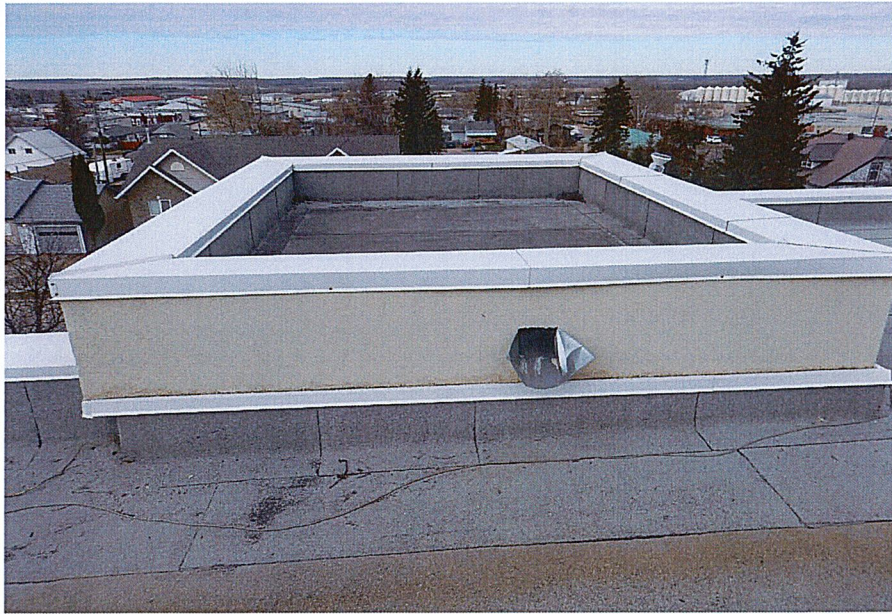
.43

This small roof on the SE corner of the upper level roof has only a poorly designed scupper drain onto the bigger roof as a drain.

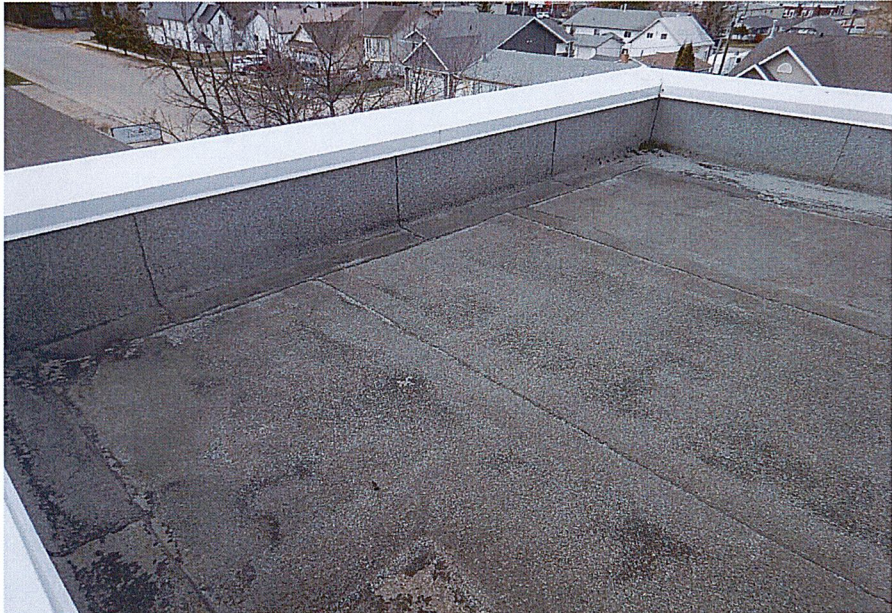
.44

One can see by the amount dirt and granule loss that this small roof is not well drained.

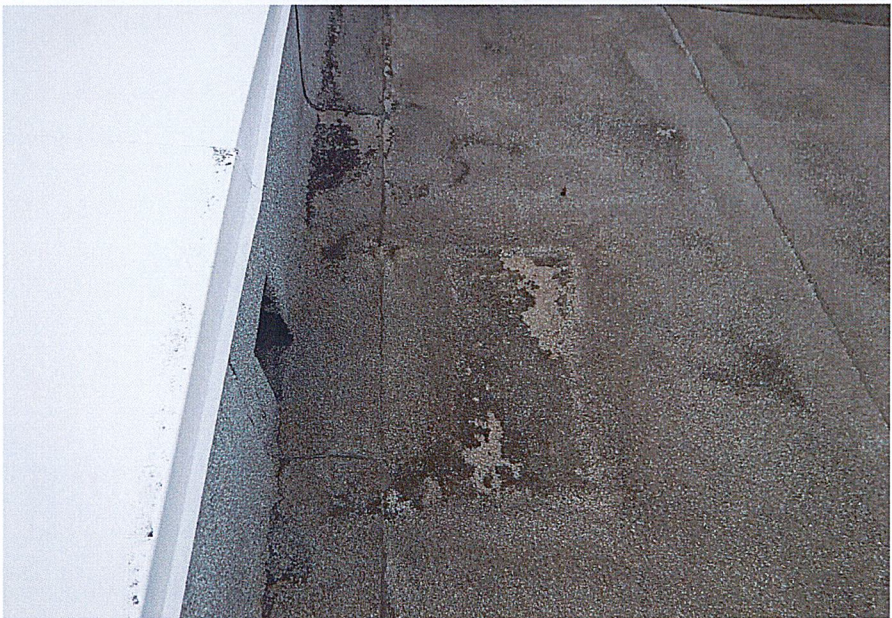
.45

The dirt and granule collection is deeper around the scupper drain.

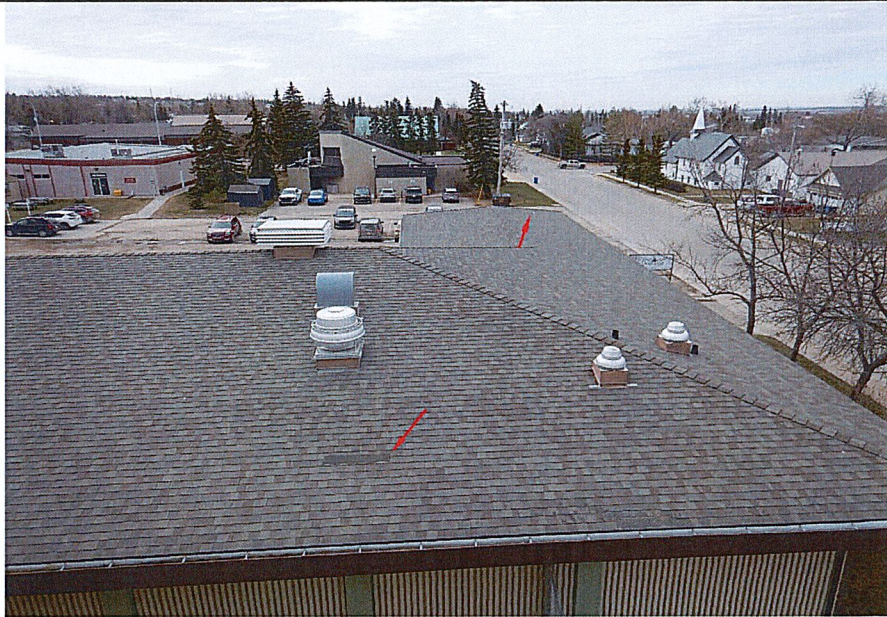
.2

From the adjoining flat roof we notice a couple of spots where there are some shingles blown off

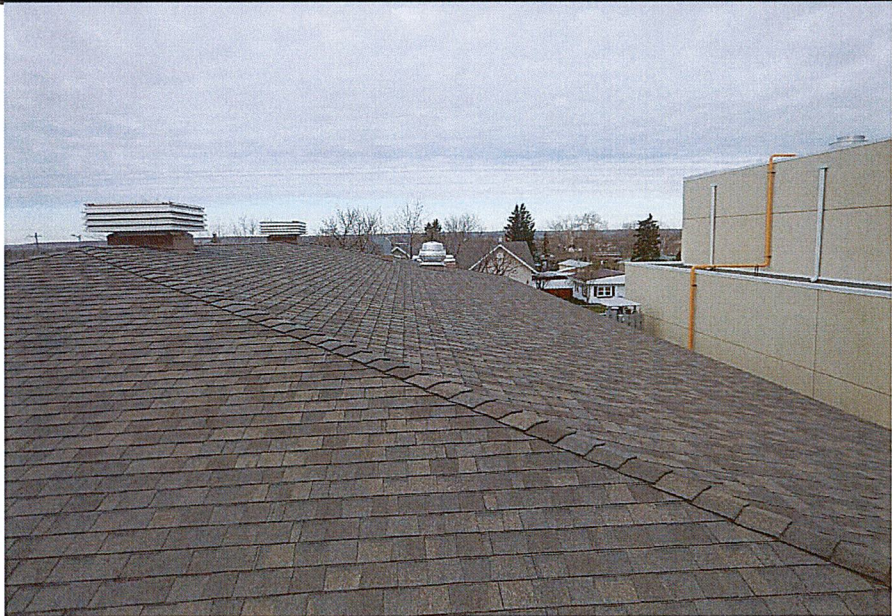
.3

From the north end of the roof a long look down the west half shows the lay of the shingles is smooth and the rows are quite straight.
