ROOF ASSESSMENT SURVEY REPORT
BEAVERLODGE POOL
91016 – 4TH AVE, BEAVERLODGE, AB

ROOF ASSESSMENT SURVEY REPORT – BEAVERLODGE POOL

Topside Consulting (2004) Ltd. has been retained to provide a Roof Assessment Report to ascertain the condition of the various roof systems on the five different areas, and give the owner a timeline for, and understanding of, the need for repairs and replacement. The building was inspected on May 4th, 2026.

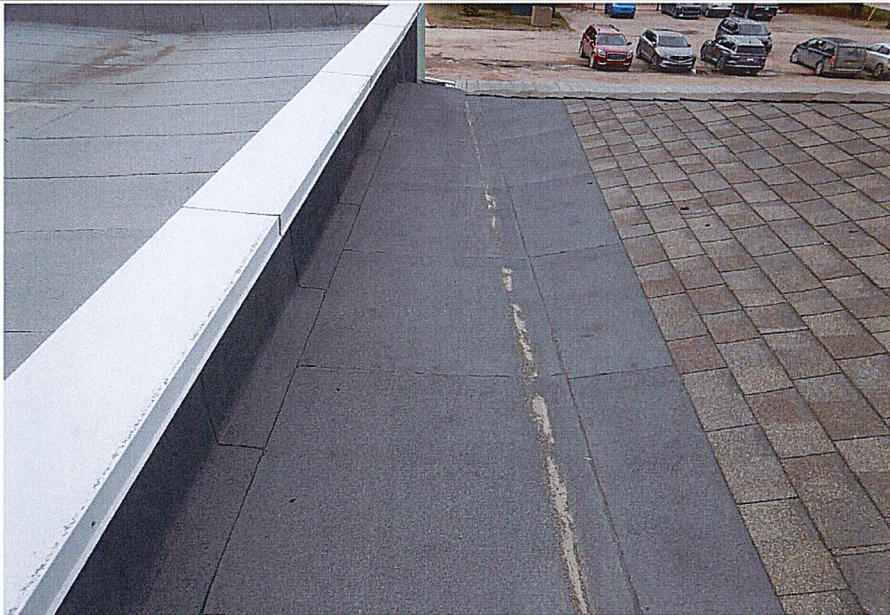
.5

The tie-in to the flat roof area of the building is down with SBS torch-on membrane across the adjoining cricket/valley. The lay of the roof and laps all appear to be quite sound.

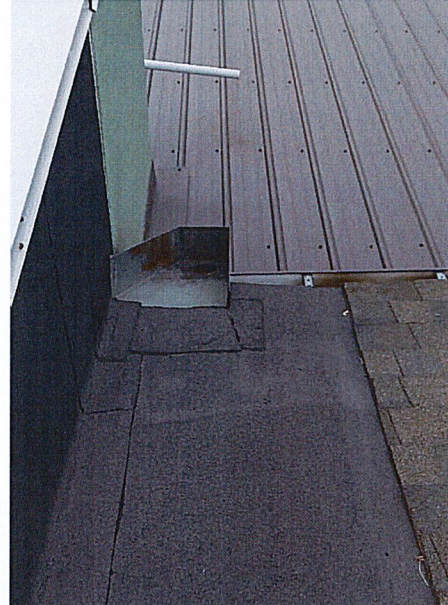
.7

The west and east end of the tie-in torch-on drain to custom modified scupper drain that drops into an eavestrough. This all looks good and drains well.

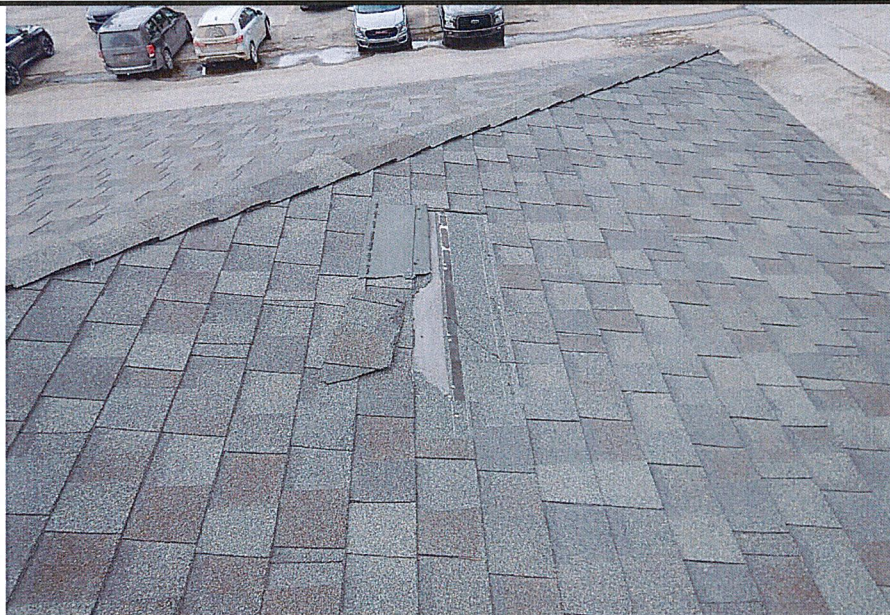
.8

On the south side there is a bit of wind damage that has removed shingles down to the underlay in one section. We noticed here that the nails in the tore shingle pieces are quite rusty.

The only recommendation for the shingle roof is replacement. It is the only way that the current system can be remediated to work as it should. The shingles should be removed, the rotten plywood and above deck framing replaced as required, then a ventilation layer added with vertical strapping and new plywood with new shingles. The details on the hips, valleys, eaves, and peaks, not to mention the curbs and penetrations, all need to accommodate this design for proper function of the new roof. Just getting quotes from interested contractors to install a new roof may well see a repeat of the existing scenario. There needs to be a set of specifications and drawings that clearly lay out the installation on all details. The budget for this work, not including the plywood, insulation, and framing replacements that will be needed, would be in the range of \$150,000.00. We will quote you the writing of specs and drawings for this work at \$5500.00 plus GST. This work should be done this year to avoid any further damage to the structure below.

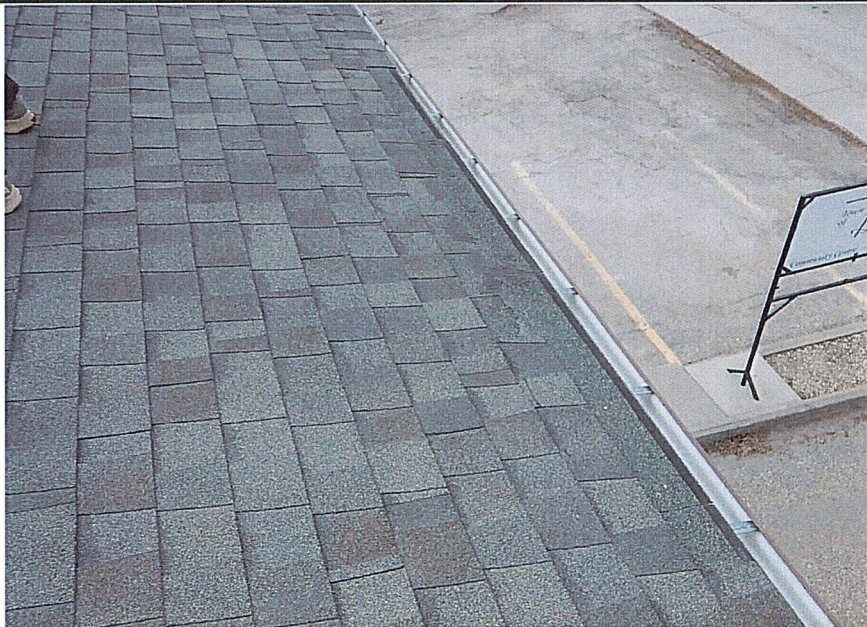
.9

Another spot where the wind removed a few shingles right at the eaves line.

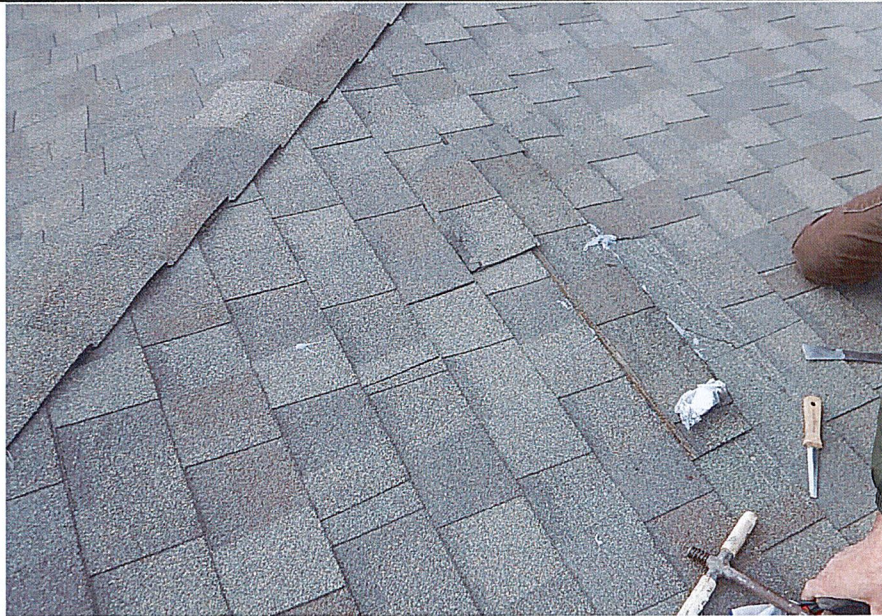
.11

The wind damage shingles were repaired by us enough to cover the worst of the gap.

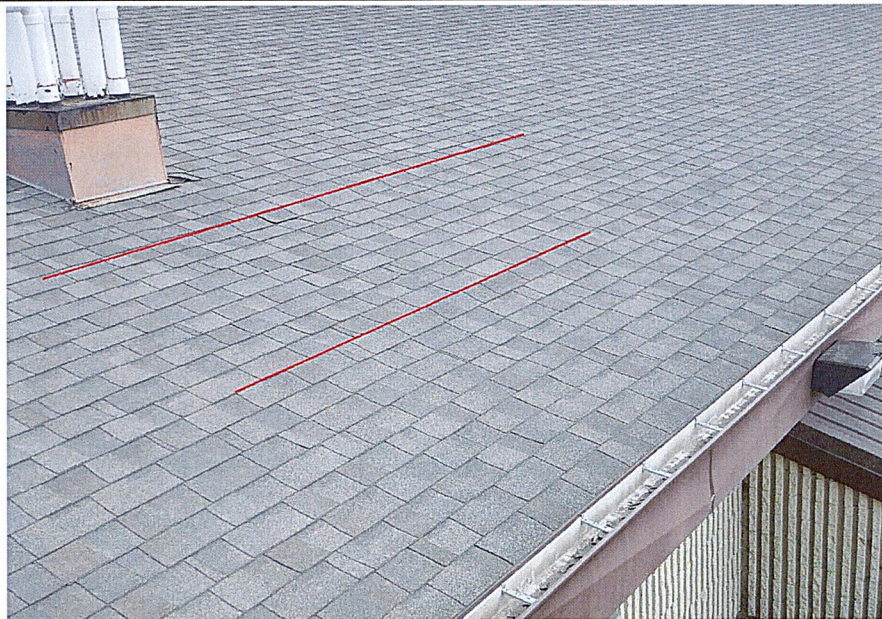
.12

Upon closer examination around the curb we noticed a couple of "dips" in the roof that appear to be roughly 4' a part. Walking on this zone was spongy but not collapse.

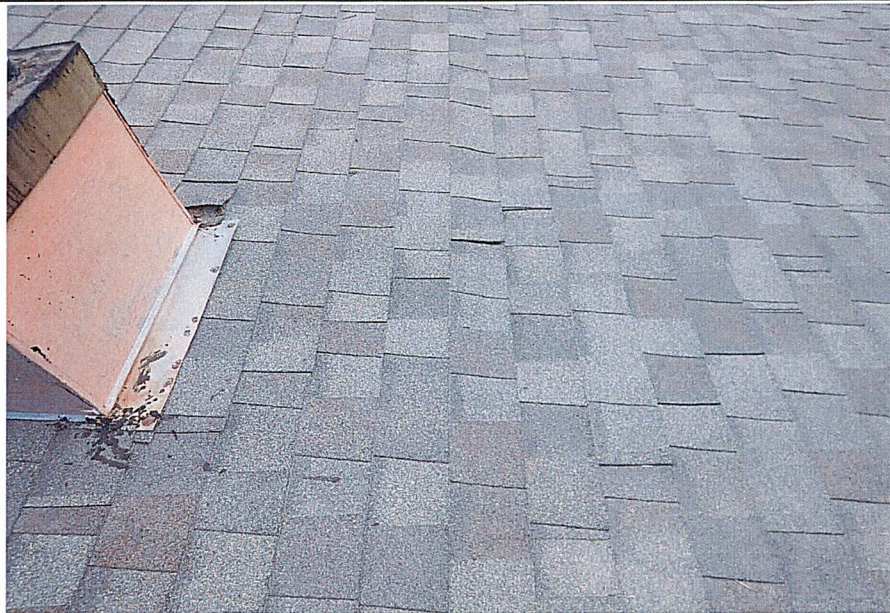
.13

Closer to the anomalies it is even more apparent the depth of swale just below the curb.

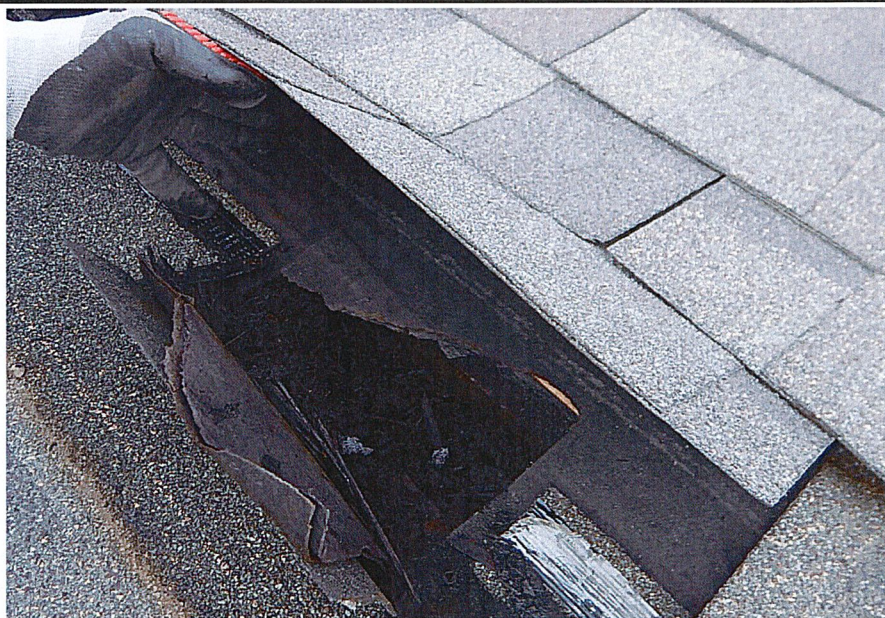
.14

We opened up this area. That black area down there - that's black rot, far enough gone that we can scoop it out with our bare hands.

The shingles were very easy to lift off - too easy, since the nails were being held by.... nothing.

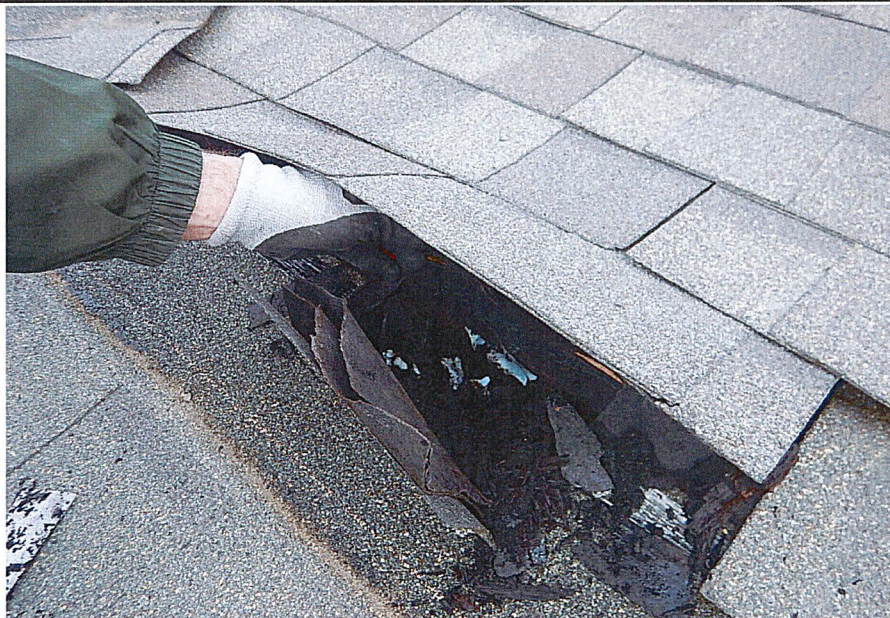
.15

We dig upward a little bit and we find styrofoam insulation. Reveals that this is a roof system that uses styrofoam on the main roof deck and has plywood directly over this.

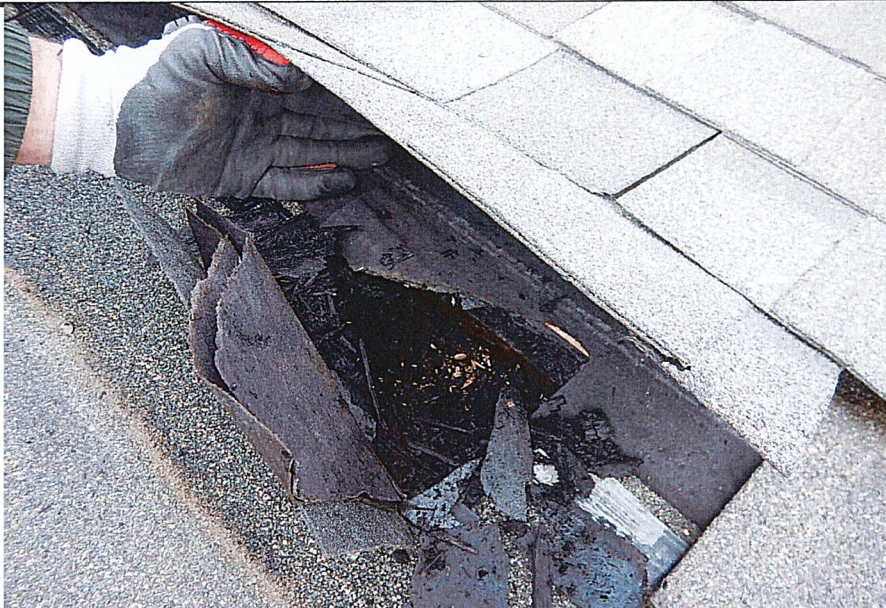
Item
.16

We dug down and found some actual wood framing that is still intact. We measured the rot down to the wood and found 3" thick of rot and rigid insulation to solid wood. No signs of ventilation under the top layer of plywood.

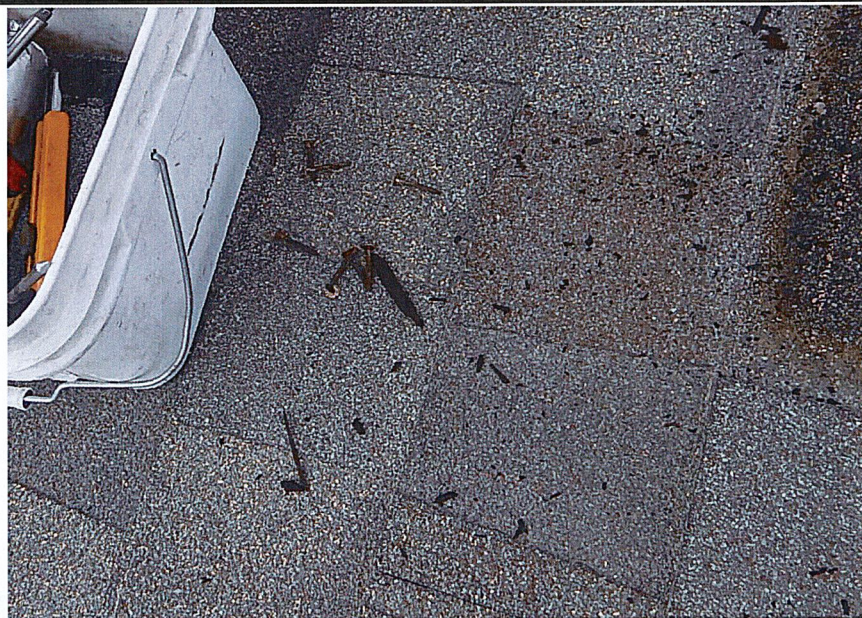
Item
.17

Look closely at just how rusted the nails are, we found a couple that were rusted off with 1/4" stubs below the head.

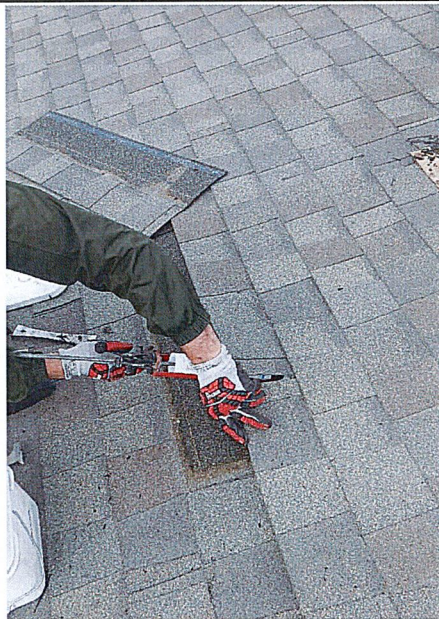
Item
.18

We used a high power adhesive/caulking to put the shingles back down so they wont blow off and should still shed water.
