Town of Beaverlodge

Arena Condition Assessment

FEBRUARY 2023

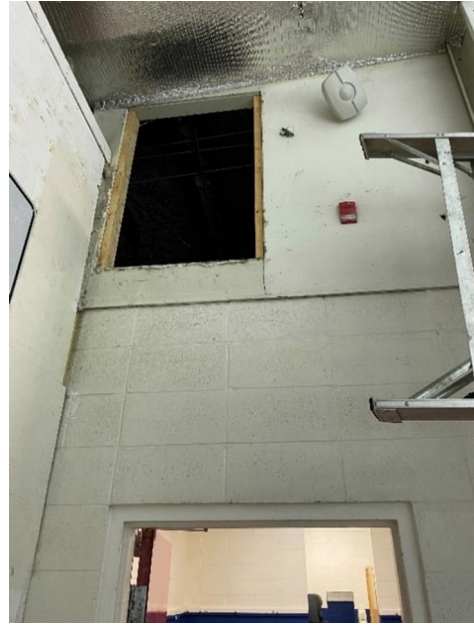
Figure 2-2 Non-Rated Access into Ceiling Area

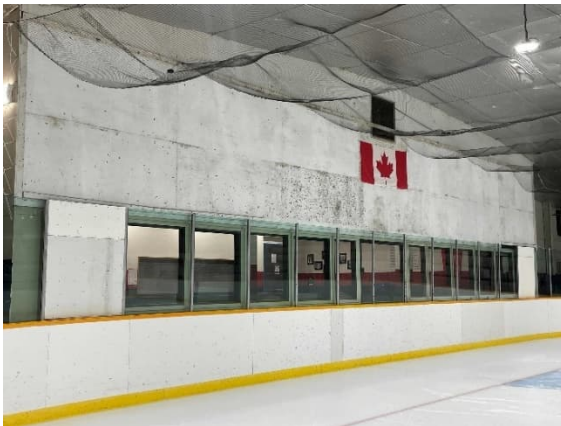
Figure 2-3 Separation Between Rink and Lobby to be Rated

- Rebuild and repair the fire separation between the lobby and the rink to meet the 1 hour required F.R.R.
- Patch and repair penetrations through rated wall assemblies.
- Replace doors between the rink and the lobby and rebuild the rough opening.
- Install fire ratings on doors as per NFPA 80.
- Install a vestibule into the ice plant to meet the required separation.

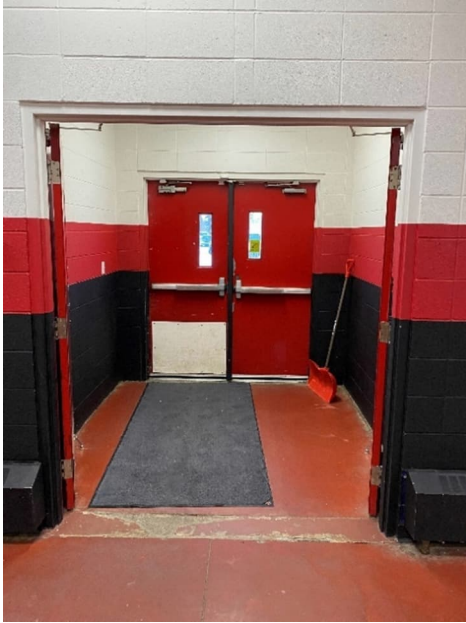
- Main entry doors to the lobby and access doors to the rink do not have automatic door operators.
- There is no dedicated viewing area with a ramp for H.C. access.

Figure 2-5 No H.C. Access Button

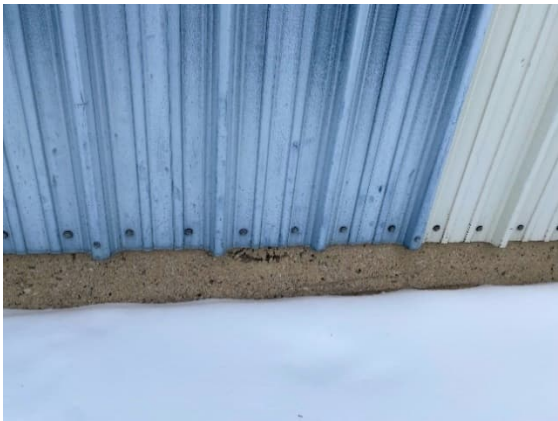
Figure 2-7 No Base Flashing

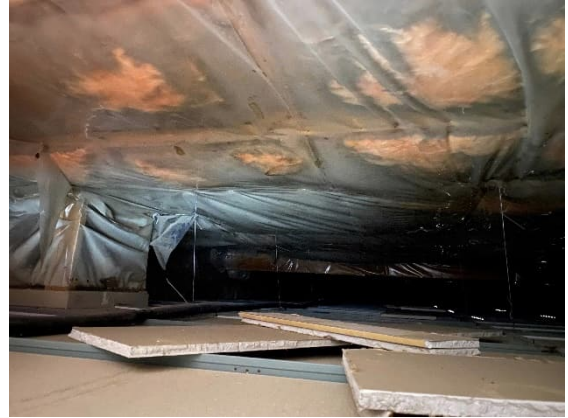
Figure 2-16 Water Damaged Fiberglass Insulation

Replace the existing metal cladding and building envelope around the rink. It is recommended to install insulated metal panels or a similar system outboard of the existing girts to reduce the thermal bridging.

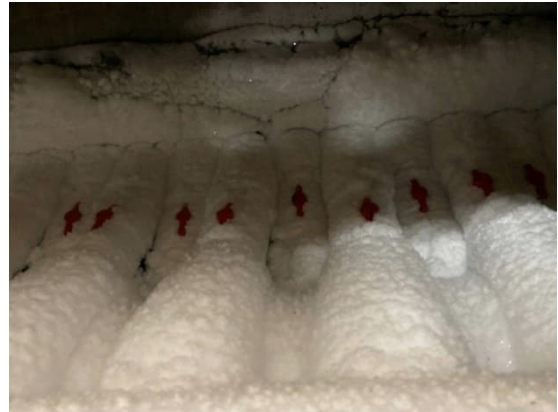
Figure 2-20 Frosted Pipes in Header Trench

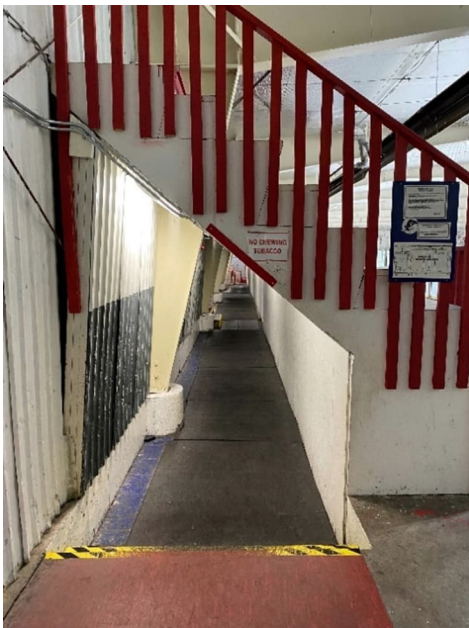
The bleachers are painted wooden planks with wood steps. They are kept in good condition and appear to have many layers of paint. The bleachers do not have a dedicated area for H.C seats and the underside is clad with painted chipboard. According to the code the underside of the bleachers that are used for storage need to be fire rated.

Figure 2-26 Underside of Bleacher

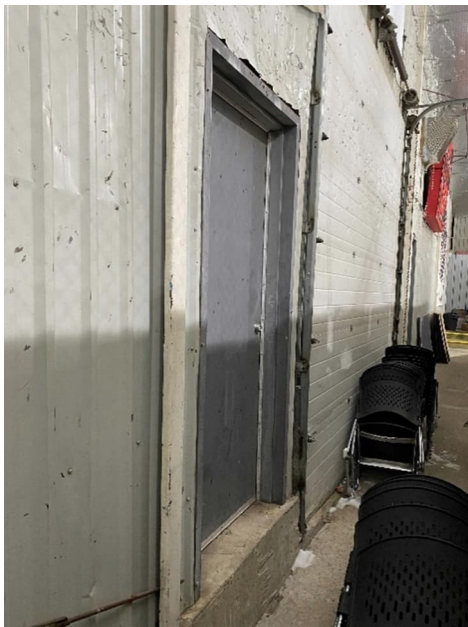
Figure 2-34 Exit Door Elevated off Ground

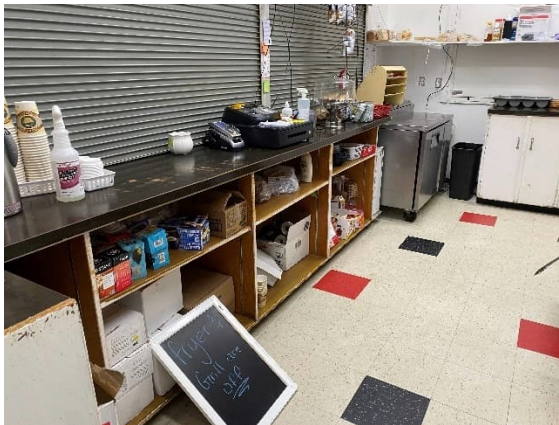
- The millwork/cabinets in the concession area are old and beyond their functional lifespan.
- The P.Lam counters are chipped and starting to peel.
- There are no closers on any of the millwork doors, and the front cabinets have had all the doors removed.
- The rolling concession doors are in fair condition, while the original wood concession window is wood and closed. The concession area needs to be separated from the remainder of the space with a 1 hour F.R.R. and thus the existing wood opening needs to be infilled with a rated assembly to match the walls.

Figure 2-44 Millwork Without Doors

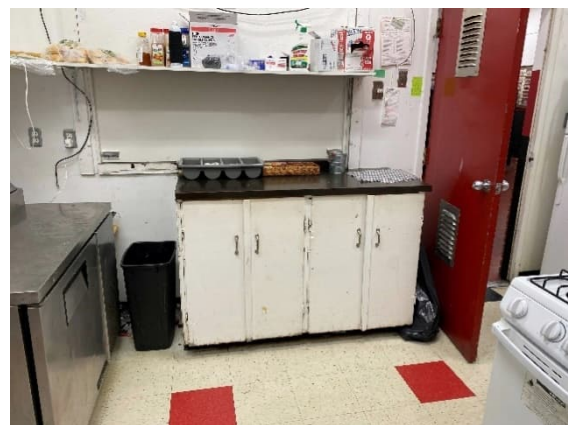
Figure 2-45 Old & Damaged Millwork

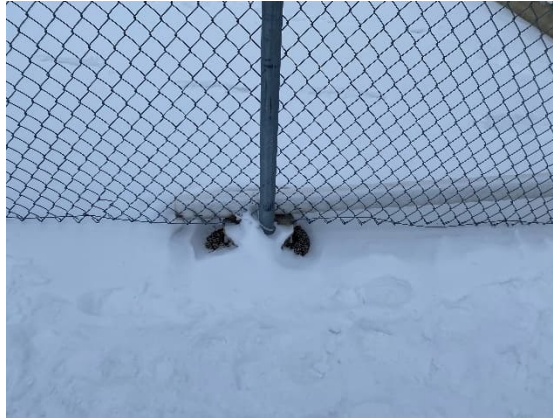
The site is in satisfactory condition. The maintenance staff indicated that the 2nd fence post along the edge of the tennis court is heaving out of the ground. Based on the location of the RWL the probable cause is water freezing and thawing that is coming off the roof.

Figure 2-52 Heaving Fence Post

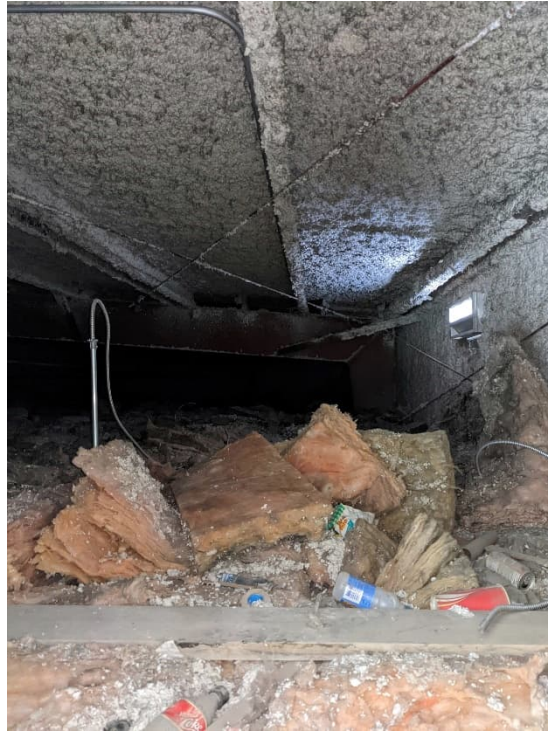
Figure 3-3 Garbage in Space Between High-Ceiling and Pre-Engineered Roof Above

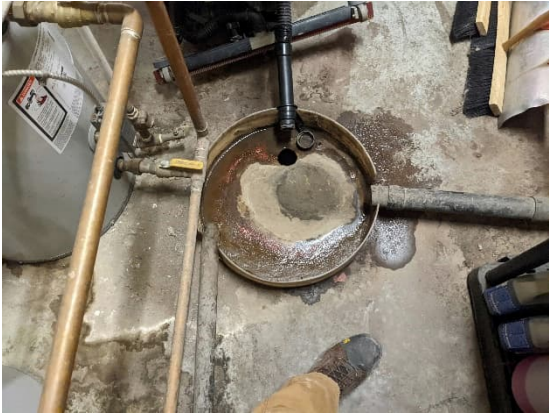
The sump pits and header trench for the rink brine system were also reviewed from within the front lobby. Where visible, the general condition of the concrete is showing mild discoloration and only minor cracking. The trench cover shelf angles and their hardware are showing signs of corrosion and discoloration.

Figure 3-10 Deterioration of Concrete in Front Mechanical Room

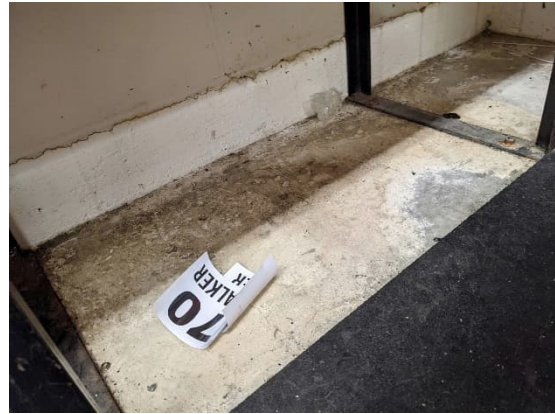
Where the addition footprint is extended, the masonry walls are all on top of 200 mm wide by 100 mm tall concrete perimeter curbs. Cracking is visible at the base wall to top of curb interface in the dressing rooms. The 190 mm masonry walls in the Zamboni Room are variable in height from their bases between old concrete curb/slab to the new curbs. The masonry wall to concrete curb interface is stepped and irregular/poorly transitioned, with some reinforcing left exposed. Portions of the old slab are left exposed and reinforcing not properly removed or any cover restored to prevent moisture infiltration into the slab reinforcing.

Figure 3-15 Cracking at Bottom of Masonry Wall and Curb in Dressing Room 5

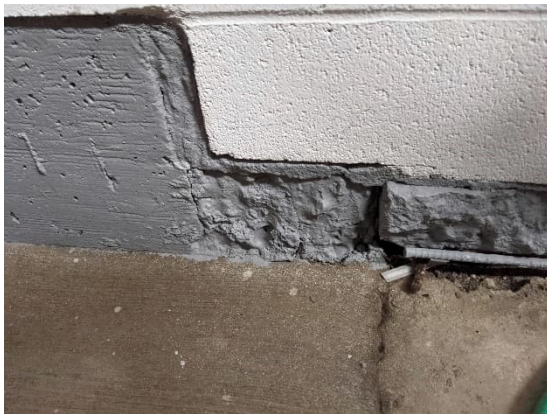
Figure 3-16 Irregular/Poor Transition in Zamboni Room Wall

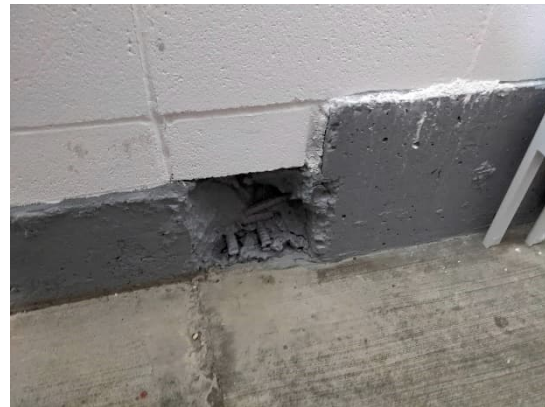
Figure 3-17 Irregular/Poor Transition in Zamboni Room Wall

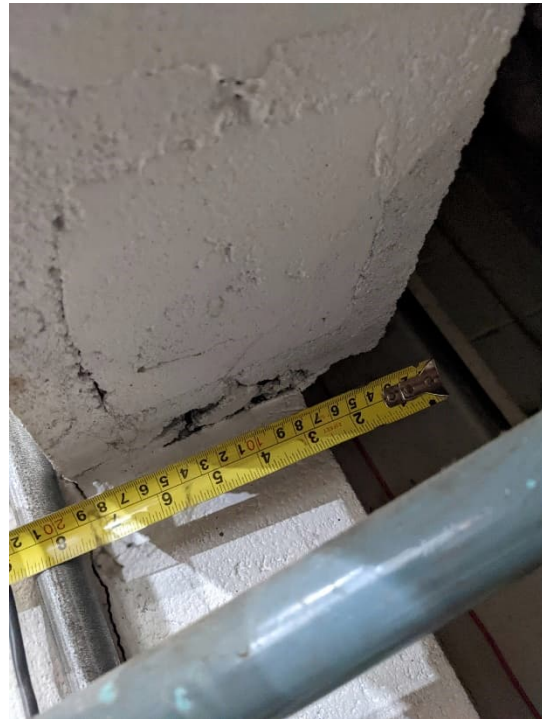
Figure 3-19 70 mm Masonry Wall Offset

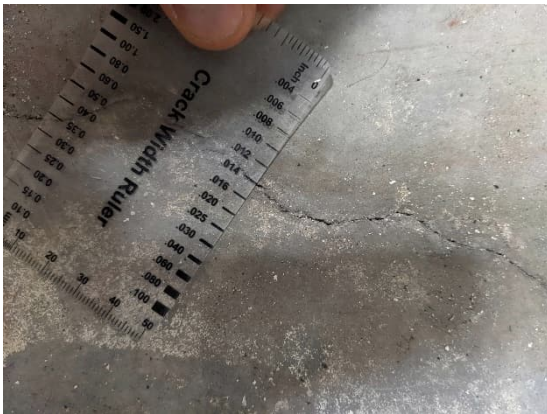
The base slabs in the dressing rooms area were reviewed in select locations. Areas near doorways and near floor drains appear to be in good condition with only minor cracking. Some cracks of roughly 0.40 mm were found in the mechanical space off the hallway. Some locations in the dressing room are showing visible discoloration of the slab and some corrosion from abandoned bench components or anchorage.

Figure 3-20 Cracking in Mechanical Room

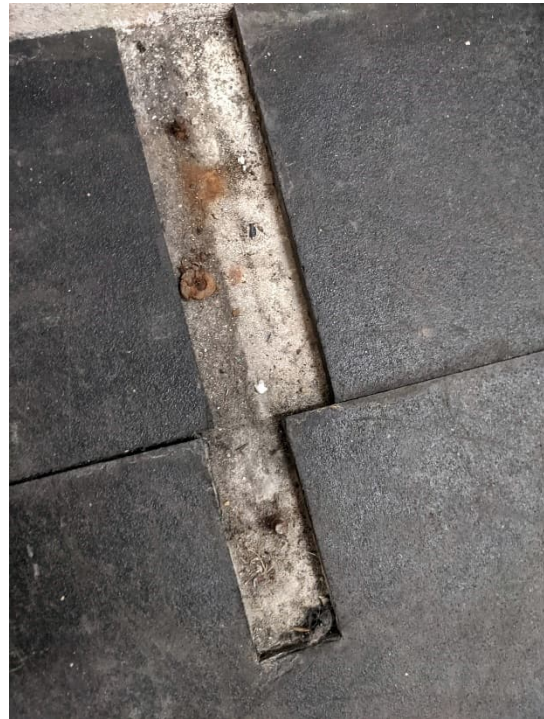
Figure 3-21 Abandoned Base Anchorage in Dressing Room 5

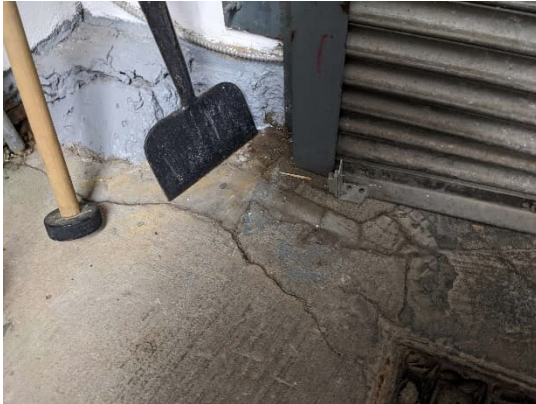
The Zamboni room floor is showing signs of wear, visible discoloration and deterioration and cracking up to 1.5 mm in size. The ice resurfer wheels are beginning to wear the concrete surface where repeated use has exposed the concrete aggregate. Not addressing this will cause further deterioration that can eventually erode the concrete cover and expose the steel reinforcing, causing further corrosion of the slab steel.

Figure 3-24 Cracking in Southwest Corner of Zamboni Room

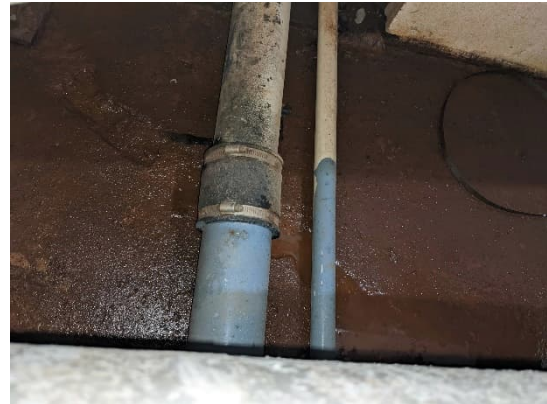
The west drainage pit concrete is in poor condition with the base slab beginning to erode around the drainpipe. This creates a lip around the floor drain, which only intensifies the concrete erosion effects of standing water. The east pit is showing some signs of discoloration and the grating supports are in relatively good condition, however some steel grating sections are showing signs of corrosion. The base of the pit is wet and dirty with extensive discoloration. And some initial signs of concrete deterioration.

Figure 3-25 Moisture and Discoloration in Base of Zamboni Room East Pit

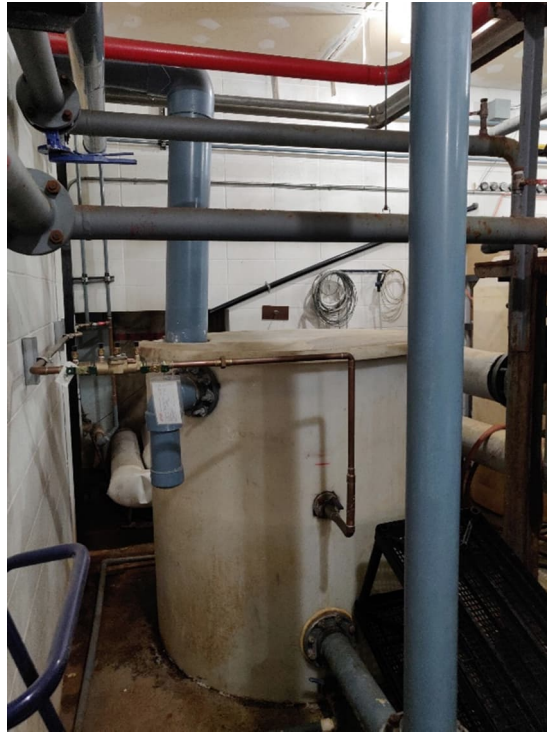
A clear impact radius of roughly 5 – 10 m can be seen around the brine tank where it is creating a major corroding effect on all steel elements in its proximity. Mechanical equipment, valves, piping and their clamps, hardware and supports are all showing signs of corrosion. The chiller skid unit is heavily corroded nearest the brine tank.

Figure 3-30 Brine Tank in Southwest Corner of Ice Plant

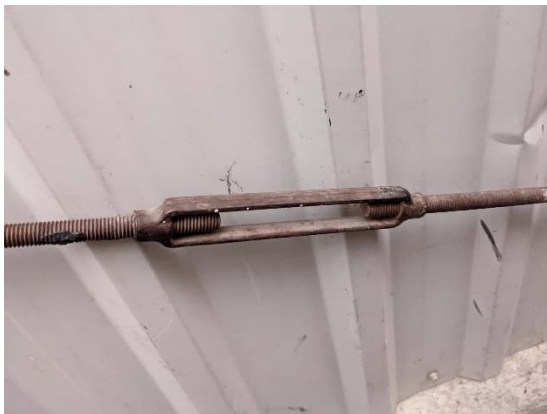
Lateral support for the pre-engineered framed structure is provided by 25 mm diameter threaded-rod and turnbuckle diagonal x-braces in select bays. There are visible signs of minor corrosion that can be seen on the cross-braces in some locations. The ends of the braces are fastened directly to the pre-engineered columns webs. This system of threaded rods and turnbuckle x-braces is provided in the roof plane as well to provide rotational stability between the pre-engineered framing bays.

Figure 3-35 Rod and Turnbuckle Pre-Engineered Brace, Minor Corrosion

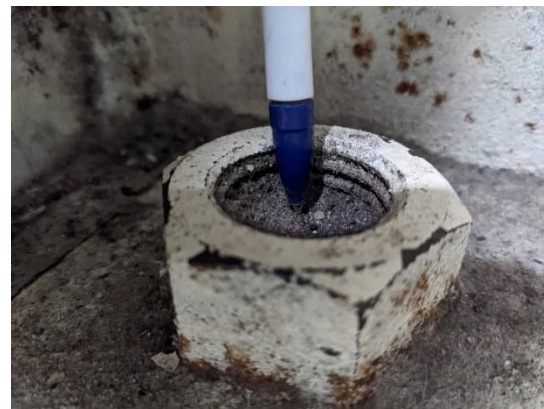
Figure 3-40 Low (Negative) Threading on Anchor Bolt

- Repair and or replace the pre-engineered framing column segment nearest to the ice plant where the brine tank is causing a major corrosion concern.
- Where anchor bolts are not projecting sufficiently, splicing or cleaning and puddle welding of the anchor bolts to the nuts is required.
- Structural Roof inspection of Main building and east addition.
- Replace the condenser unit steel support frame with galvanized steel framing.
- Repair concrete slab where debonding from wall curb.
- Clean and re-apply top finish on worn slab surface.
- Wire brush clean and repaint pre-engineered steel.

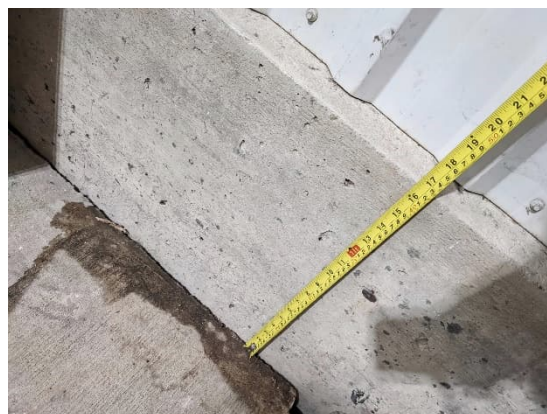
The main arena spectator area is built on a structural base slab. Where visible, the concrete base slab is in generally good condition with minor cracking in some locations. Around the slab perimeter, where the slab meets the foundation wall/curb, debonding of the slab to curb interface was visible. Some visible efflorescence as well as frost was found along the wall/curb and base slab interface. Some areas of the main level slab are visibly worn and cleaning, reapplication of finish is recommended. The slab was not visible or accessible beneath the bleachers.

Figure 3-41 400 mm Tall Curb and Slab Interface Debonding

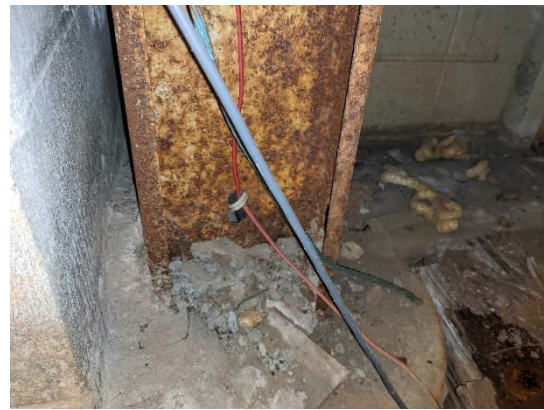
As mentioned in Section 3.3.2, the pre-engineered framing column nearest the ice plant room is experiencing extensive corrosion and even moderate section loss in some parts. The corrosion experienced here occurs along the bottom 1,000 mm -1,200 mm of the column base and, where visible, around the baseplate and anchorage.

This will need to be addressed as an immediate concern. The column will need to be properly exposed, cleaned and a more comprehensive review of the extent of the corrosion will be required. Investigation here is an item requiring immediate attention. Otherwise, the visual inspection of the pre-engineered portal frames in the arena, along with their bases and anchorage are in good condition with only minor corrosion found at some locations.

Figure 3-43 Corroding Pre-Engineered Steel Column Near Brine Tank

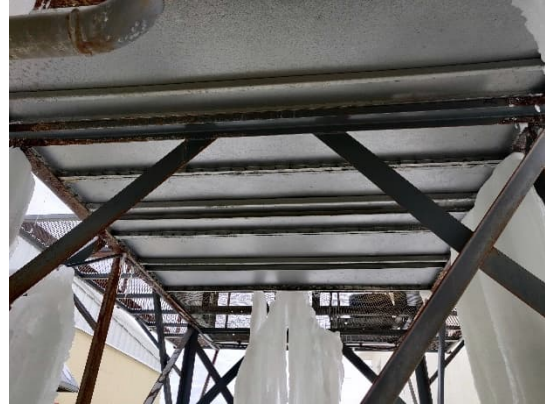
The overall condition of the steel frame varies from element to element, where there is some visible corrosion found on many of the platform elements and some of the diagonal bracing. The bases and their anchorage are showing signs of corrosion where they are beginning to bleed, stain and discolor the tops of the concrete foundation piles. Substantial amounts of frozen water coming from the underside of the unit was visible at the time of the review. This suggests a high-moisture atmosphere for some of the frame elements and there was no indication of any of the steel elements having been galvanized. Only a standard primer finish was provided to this framing, no galvanizing.

Figure 3-47 Condensing Unit Steel Frame Corrosion and Ice

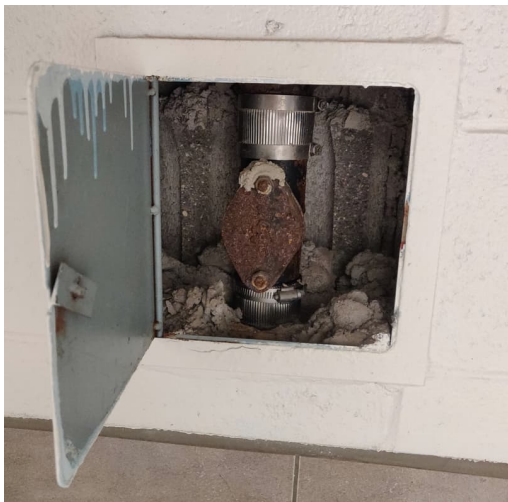
The building has a buried sanitary main which collects drainage from the plumbing fixtures installed in the building and connects to the municipal service on-site. Most of the sanitary system could not be observed, but the original sanitary risers at cleanout access panels were observed to be cast iron. The cast iron risers are showing significant surface corrosion. Drainage from individual plumbing fixtures is a variety of PVC, copper and coated brass materials, generally in fair condition.

Figure 4-1 Typical Cast Iron Sanitary Riser

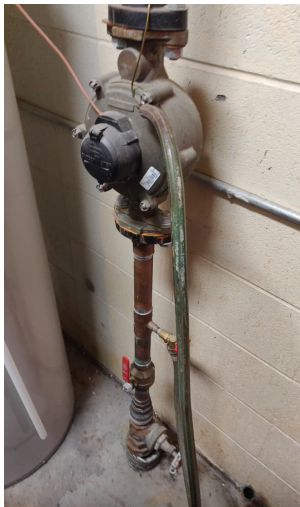
Domestic water for the building is supplied by a 40 mm water entry within the mechanical room in the south side of the building. The current water entry is too small to permit future sprinkler system installation. The buried portion of the water service appears to be a larger diameter cast iron piping, which immediately transitions to 40 mm copper after penetrating the mechanical room slab. The entry does not appear to have a backflow preventer installed but is equipped with a water meter and a shutoff valve. It is recommended to install a backflow preventer to protect the municipal water supply against backflow from the building. A backflow preventer is currently installed on the make-up line feeding the ice plant.

Figure 4-3 Domestic Water Service Entry in South Mechanical Room

- Install backflow preventer on domestic water entry.
- Add pipe supports in mechanical room.
- Monitor piping in older areas of the building for leaks, consider replacement of older plumbing piping when leaks begin occurring.

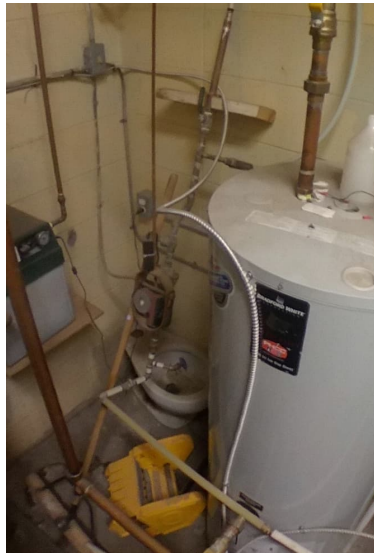
Copper distribution piping connecting to plumbing fixtures is used throughout the building for both hot and cold water piping. Portions of the domestic water piping appear to have been replaced, such as near the water heating equipment. Some of the replaced domestic water piping in the south mechanical room is PEX and is run haphazardly and is not properly supported. We recommend adding additional pipe supports to secure this piping. The typical

Figure 4-5 Haphazard Domestic Water Piping in Mechanical Room

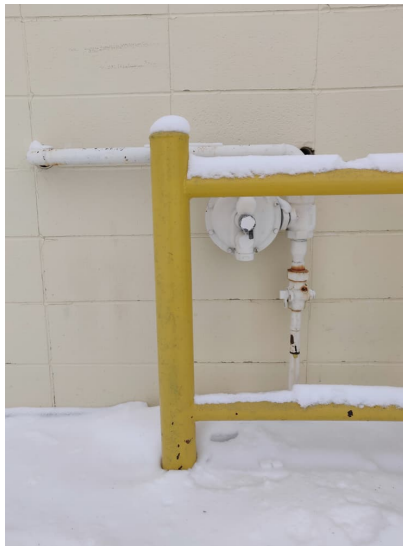
Figure 4-24 Building Gas Regulator

Natural gas is provided to the building from the gas service on the south side of the building, equipped with a regulator set on the outside of the building and gas meter inside the south mechanical room. Additional regulators are located downstream of the main regulator to reduce the pressure for appliances requiring low pressure.

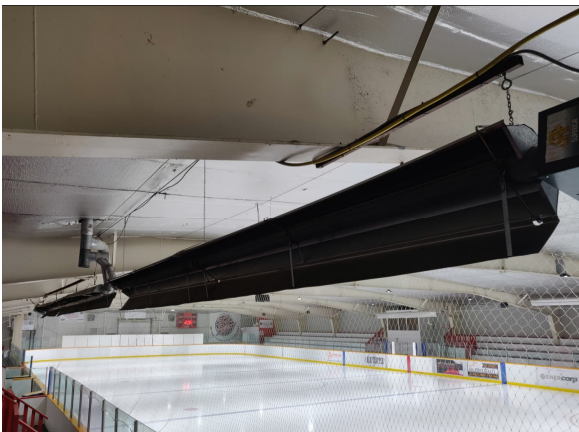
Figure 4-28 Typical Tube Heaters in Arena

The arena is heated only by four infrared tube heaters located above the stands on the perimeter of the rink, manufactured by Superior Radiant Products and Vantage. A fifth tube heater is located in the Zamboni Room adjacent the arena. All of the tube heaters appear to be quite old and appear to be at end-of-life. We recommend replacing the tube heaters. The galvanized steel tube heater flues are showing moderate corrosion and should be replaced at the same time as the heaters.

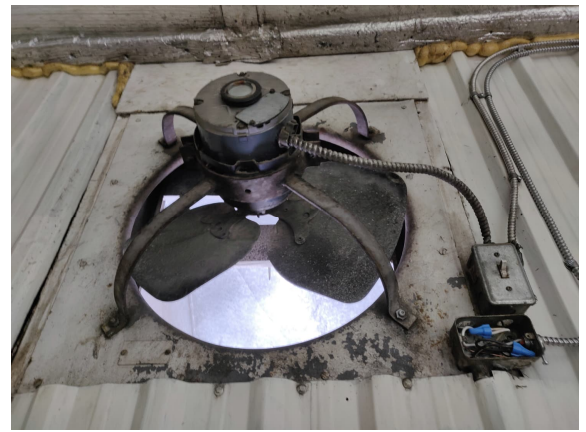
Figure 4-29 Typical Arena Exhaust Fan

The arena has three exhaust fans installed in the envelope, without backdraft dampers, and has a relief grille in the wall to draw air in through the attic above the lobby area of the building. The exhaust fans are not typically used by building operators. This means that there is no ventilation when the propane ice resurface is operating. Lack of ventilation could lead to build-up of hazardous gasses within the arena. Additionally, ASHRAE 62 outdoor air requirements are not met for the arena. Furthermore, the exhaust fans appear to have passed their expected lifespan. We recommend replacing the exhaust fans and installing a gas detection system (CH₃, CO, NO_x) within the arena to detect and control hazardous gasses. We also recommend completing a ventilation study to verify ASHRAE 62 compliance for the arena before replacing the fans. Finally, we recommend conducting a review of the building operation procedures to ensure the exhaust fans are operated when the building is occupied by the public and when the ice resurfer is being used. Alternatively, the fans can be controlled based on a timer synchronized with typical hours of operation.

- Replace the arena exhaust fans and install a timer to control fan operation.
- Install a gas detection system for the arena and interlock controls with exhaust fan operation.
- Complete an ASHRAE 62 ventilation study to confirm ventilation rates.
- Install a ventilation system for the Zamboni Room to control hazardous gasses.

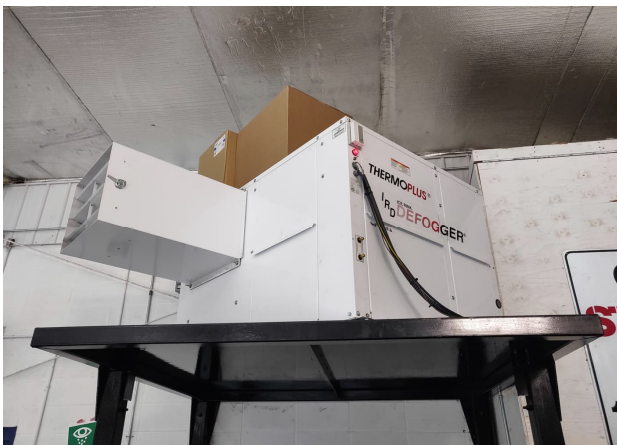
Figure 4-30 Typical Dehumidifier in Arena

The arena is also equipped with two Thermoplus Ice Rink dehumidifiers, (circa 2016) to control humidity within the arena. The humidifier drains are heat traced and run through the building envelope to the exterior. No issues were identified regarding the dehumidifiers.

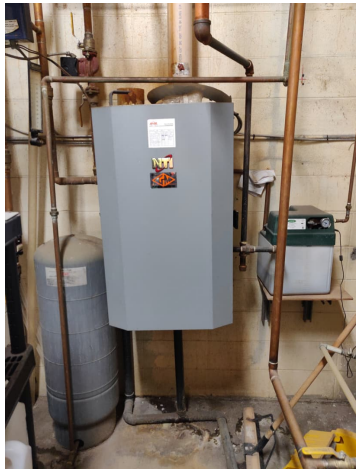
Figure 4-32 Heating System Boiler

The original building areas are heated by a single natural gas-fired NTI wall-hung condensing boiler (116 kW, Circa 2008). The boiler also provides hot water to the building via the indirect domestic water heaters. The boiler drain does not have a condensate neutralizer, and may therefore cause corrosion of the cast iron sanitary drainage system. We recommend installing a condensate neutralizer to extend the life of the sanitary drain. The PVC boiler flue vent appears to be stained from condensate or a roof leak, likely from metal flashing at the roof termination. The escutcheon at the ceiling is also damaged. We recommend replacing the corroding/leaking vent termination components and escutcheon to maintain the fire separation in the mechanical room. While the boiler still has approximately 10 years in its expected service life, building staff indicated that there have been problems with the boiler in the past, although the boiler is currently working properly. The combustion air for the boiler is provided by an opening in the wall. We recommend clearing the debris building up on the combustion air screen and installing an arctic trap to reduce cold air infiltrating the mechanical room.

- Install a condensate neutralizer on the boiler condensate drain.
- Repair corroded/leaking termination for boiler flue vent and replace damaged escutcheon.
- Install arctic trap on combustion air duct and clear debris from screen.
- Replace damaged baseboard heaters and heater in shower enclosure (approximately five heaters).
- Replace all cabinet exhaust fans in original building area.
- Replace electric unit heater in lobby.
- Complete an ASHRAE 62 ventilation study.
- Install a new air handling unit and distribution ductwork to ventilate the building, following ASHRAE 62 study.

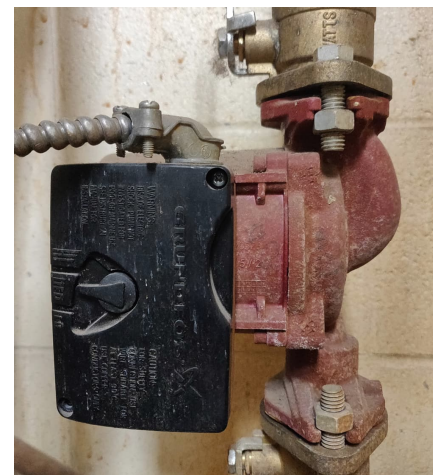
Figure 4-35 Typical Circulator Pump in South Mechanical Room

The heating system has three similar multi-speed Grundfos circulator pumps (Circa 2007, 2010 and 2011). These pumps circulate heating fluid through the boiler, supply heating fluid to the building, and supply heating fluid to the indirect domestic water heaters. The 2011 pump is missing the cover for the wiring enclosure. The expected life for an in-line circulator pump is only 10 years, so these pumps are all at the end of their expected life and should be replaced.

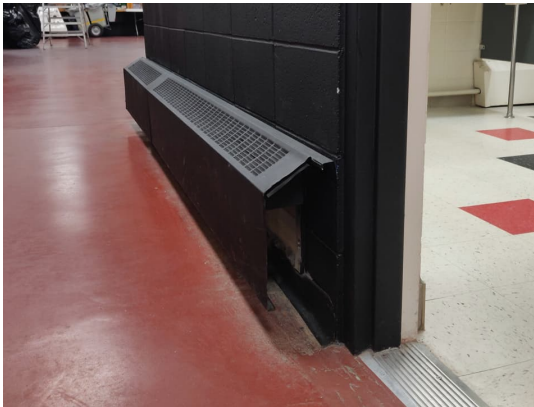
The building is heated by baseboard heaters within each perimeter space, which are controlled by electronic wall-mounted thermostats. We recommend replacing the baseboards in a few locations where they are damaged and missing end-caps (at least three locations). Baseboards in other areas can be sanded and repainted to restore their aesthetic. There is a baseboard located in a shower enclosure in the south-most player changeroom, which is corroded from water splashing on it. We recommend replacing this heater further up on the wall out of the splash-zone for the shower.

Figure 4-36 Typical Baseboard Heater Missing End-Cap

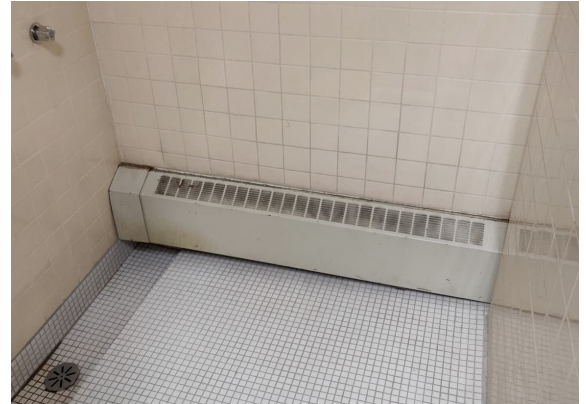
Figure 4-37 Baseboard Heater in Shower Enclosure

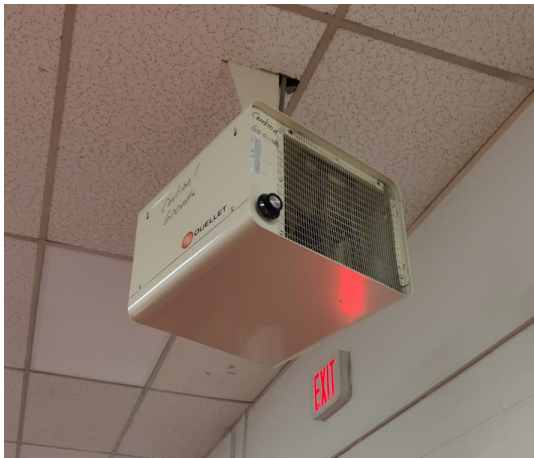
Figure 4-38 Electric Unit Heater in Lobby

An electric Ouellet unit heater (10 kW, Circa 2008) is installed in the lobby, near the main building entrance has reached the end of its expected lifespan and should be replaced.

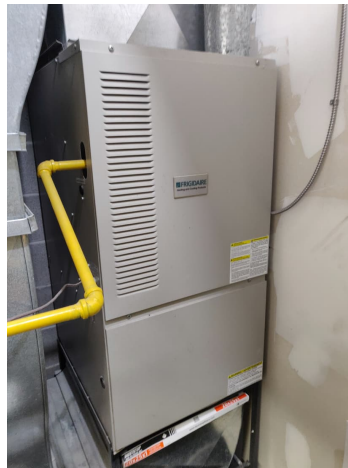
Figure 4-40 Furnace Serving Change Room Addition

The change room addition is heated and ventilated by a single Frigidaire gas-fired furnace (42 kW, Circa 2005). The furnace has just reached the end of its expected service life this year and should be replaced. The galvanized steel

furnace ductwork and venting generally appear to be in fair condition and are relatively free of corrosion. The furnace air filter appeared to be relatively clean. A humidistat is provided for the furnace system, but the furnace does not appear to have a steam grid, so it is unclear if there is a duct-mounted humidification grid above the ceiling, or if the humidistat controls the exhaust system. Building staff have noted that player jerseys left to dry in the north player changeroom freeze overnight. This is likely, in part, due to the furnace thermostat being located in the interior furnace room where it does not perceive building heating demand. We recommend relocating the furnace thermostat to the north changeroom where the freezing is occurring. A locking cover can be installed over the thermostat to prevent tampering. If this solution does not resolve the freezing issue, corrections involving the building envelope may be required. It was also noted that the furnace fan is set to automatic mode, meaning that there is no outdoor air delivery to the change room addition spaces unless the furnace is actively heating. We recommend adjusting the controls so that the furnace fans run continuously while the building is occupied, and recommend completing a ventilation study to confirm that outdoor air rates comply with the ASHRAE 62 standard.

- Replace the furnace serving the change room addition.
- Relocate furnace thermostat to north-most player change room, option to add lockable cover.
- Adjust furnace fans to run while building is occupied.
- Complete an ASHRAE 62 ventilation study.
- Replace addition washroom exhaust fans in approximately 5 years.

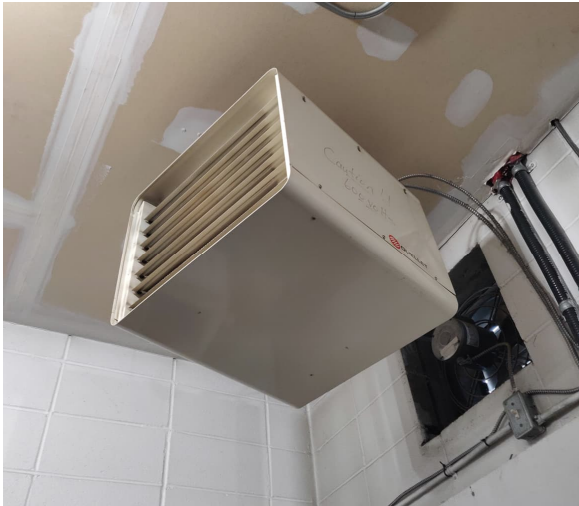
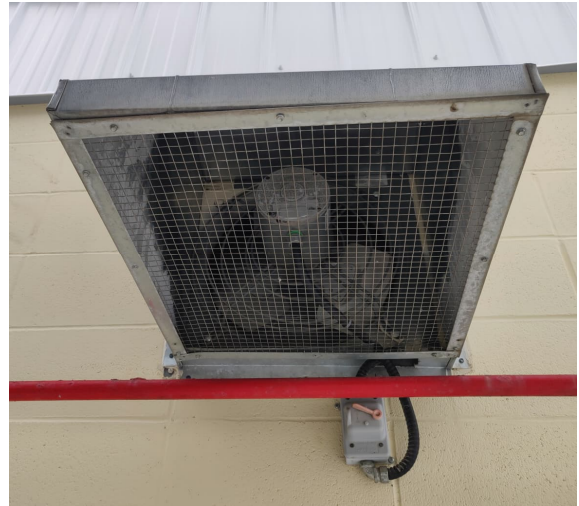
The ice plant machine room is heated with an electric unit heater with thermostatic control. Wall-mounted propeller supply and exhaust fans with a set of dampers comprise the ventilation system, neither of which were operating at the time of review. A gas detection system is in place with PPM readouts for ammonia located outside the man-door

Figure 4-41 Unit Heater and Propeller Fan in Machine Room

Figure 4-42 Second Propeller Fan Serving Machine Room

- Build vestibules for the interior entrances to the machine room.
- Seal all openings to restore the integrity of the fire rated walls.
- Install remote ventilation activation switches and emergency shutdown switches outside entrances to the machine room.
- Revise ventilation system controls to provide the minimum airflow rate while the ice plant is in operation.
- Install additional PPM readouts (two) so that there is one at each entrance to the machine room.
- Install an eyewash station to ANSI Z358.1.

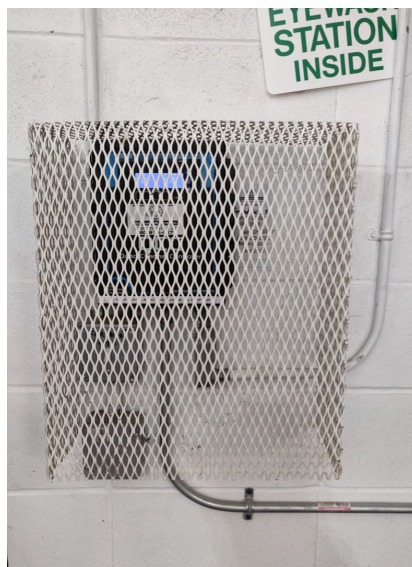
A sign in the arena directs to the machine room for an eyewash station, which is a single plastic bottle located inside an unmarked cabinet in the machine room and has passed the expiry date printed on the bottle. We recommend installing a new conspicuous wall-mounted eyewash meeting the ANSI Z358.1 standard.

Figure 4-43 Gas Detection System and Eyewash Sign Outside Machine Room

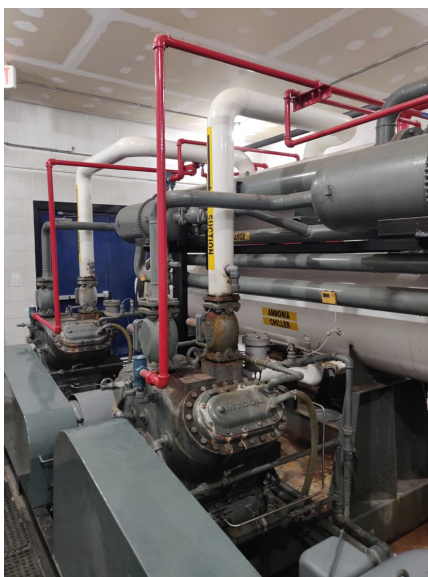
Figure 4-44 Ice Plant Compressors

The ice plant is configured such that compressor #1 can provide chilled brine to both the hockey rink and the curling club, and compressor #2 can only supply cooling to the curling club. The compressors are approximately 20 years old, but have undergone major service about 3 years ago. Currently, compressor #2 is shut down due to a low-voltage fault, presumed to be a suction line issue. Additionally, it is known that the chiller is failing due to corroded heat exchanger tubes and requires immediate replacement. From a visual review of the ice plant equipment, it is apparent that most of the equipment, including compressors and pumps serving the hockey arena have reached (or are close to) the end of their expected service life. The majority of equipment and piping is heavily corroded where uninsulated, a fitting on the brine piping appears to be leaking brine on the floor of the ice plant, and there is evidence of past oil leaks. Only a few components, such as one of the brine pumps serving the curling club, appear to have any service life left.

- Replace the chiller immediately.
- Full replacement of ammonia plant in near future.
- Replacement of brine header within header trench.

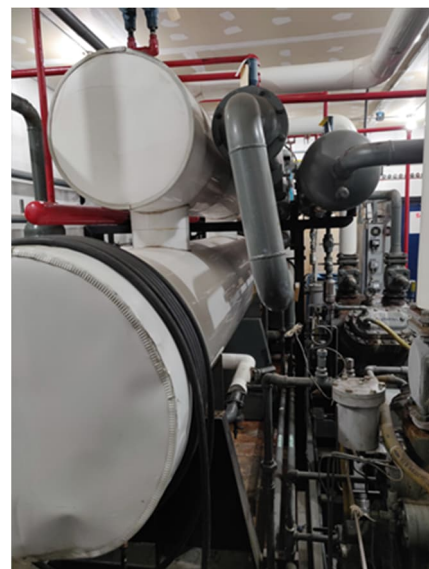
Figure 4-45 Ice Plant Chiller

Due to the failing condition of the chiller, we recommend immediate replacement of the chiller. A full replacement of the ice plant should also occur in the near future to restore the service of life of the ice plant. This replacement should also include the outdoor piping and condensing unit. Continuing replacement of individual failed components into the future likely require more downtime and a higher overall cost.

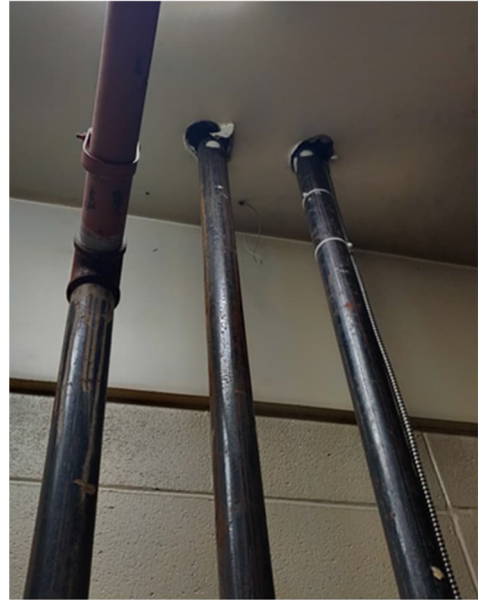
Figure 4-50 Gap in Fire Separation at Natural Gas Piping Through South Mech Room Ceiling (Typical)

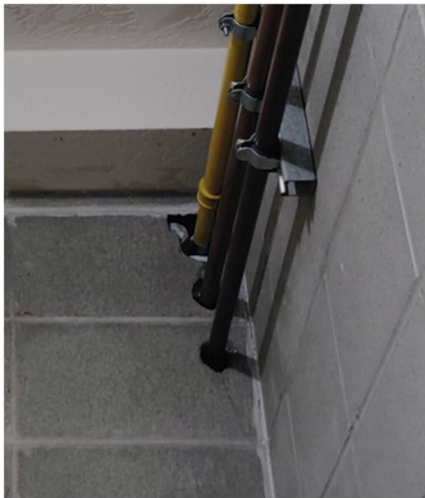
Figure 4-51 Gap in Fire Separation at Piping Through Furnace Room Wall (Typical)

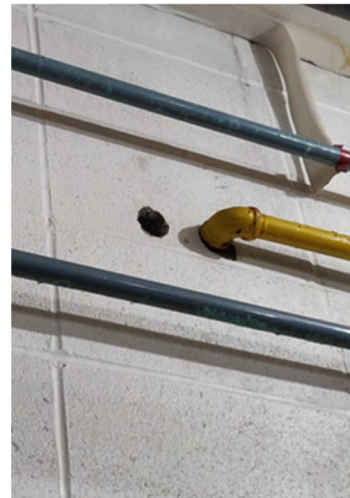
- Vestibules are required at the doorways from the arena and Zamboni Room.
- Fire rated walls must be sealed around pipes and other penetrations.
- Ventilation system activation-only switches and ammonia plant emergency shutdown switches must be located outside the interior entrances to remotely activate the ventilation system and disable the ammonia plant.
- The ventilation system does not provide the minimum airflow rate while the plant is operating. Rupture ventilation airflow rate was not confirmed.

Figure 4-52 Gap in Fire Separation at Piping Through Ice Plant Machine Room Wall (Typical)

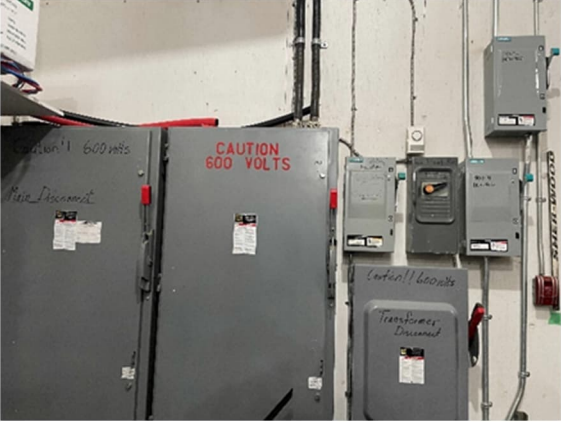
Figure 5-5 Mix of New and Old Disconnects

No changes are required to the utility service at this time, if the site increases demand this will need to be examined more closely and the utility will need to provide peak loading information. The 600 V system could be replaced with new panels to replace the gutter and clean up the space. The power distribution should be located in a clean, dry room.

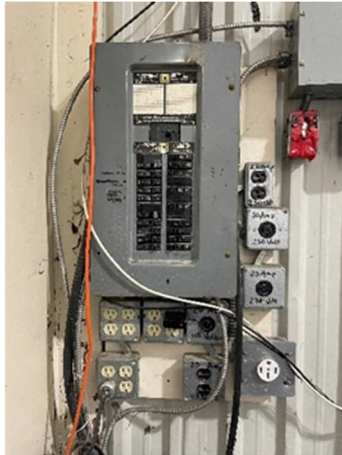
Figure 5-9 Bleacher Power Panel (accessible to public)

Because of the age of the panels, we recommend a project to replace remaining original panels, approximately nine panel boards, in the next 1 to 3 years.

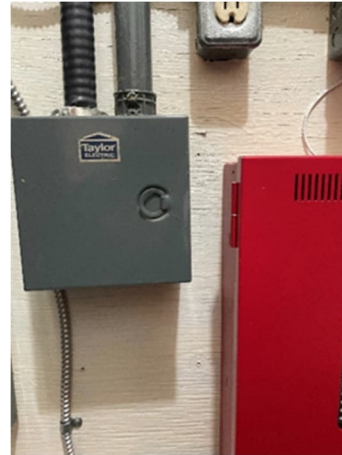
Figure 5-10 High Risk Junction Box (likely replacing the old service connection to the panel in the office)

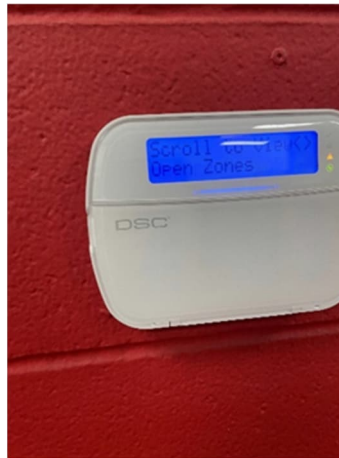
Figure 5-11 Security Keypad

The doors have position switches and there is a security call out panel HS2016 with battery back up, likely used for fire alarm call out along with security. There is no CCTV system or monitoring.

- Implement annual testing and maintenance of the security system and fire alarm call out.

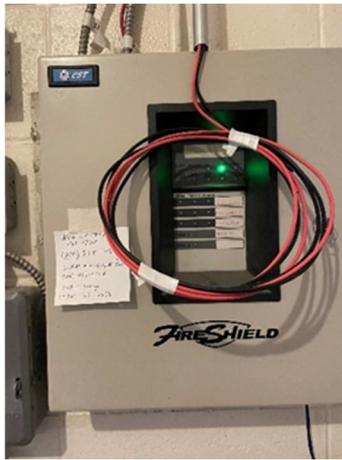
The new main fire alarm panel is a AutoCall Fire Control 4007. It is powered down and locked. The existing fire alarm system is in a state of replacement with the new fire alarm system.

The fire alarm system was not reviewed after this was determined. The new fire alarm system should be verified by a professional engineer and the drawings must be authenticated.

Figure 5-12 Main Fire Alarm Control Panel (located in Office, being replaced)

- That fire alarm drawings be created for the building and posted at the front door. A fire alarm annunciator mounted at the front door.

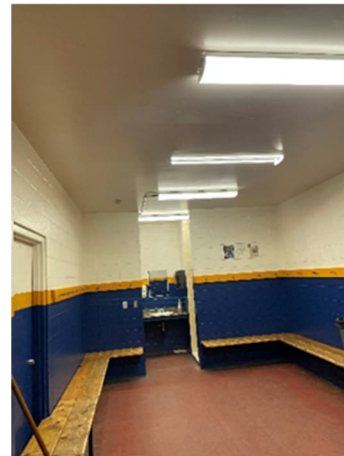
Luminaires in dressing rooms have no Polycarbonate lens and are not rated for a damp environment. It is recommended to replace them with Polycarbonate lens type and be rated for damp location.

Figure 5-17 Arena Change Room LED Lighting Without Mechanical Protection

- Replace dressing room luminaires with 'unbreakable' Polycarbonate lens type and be rated for damp location.
- Consider mechanical protection guards for rink lighting.
- The concession lighting should be food grade/ 'unbreakable'.

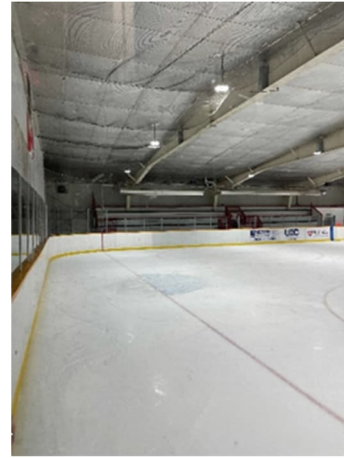
Luminaire above the bleachers are pendant style LED matching the rink lighting. The rink lighting is exposed LED and may not be vandal resistant.

Figure 5-19 Arena LED Lighting Without Mechanical Protection (Def)

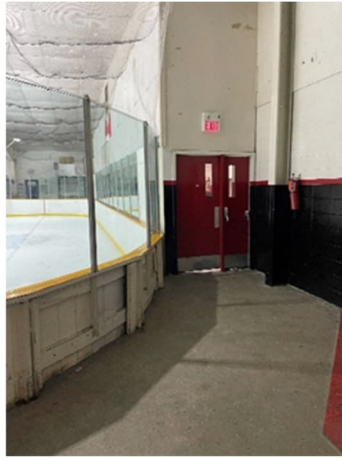
Figure 5-20 Exit Sign

The number of emergency lights in the arena is not sufficient to meet code requirements. It is recommended to add new emergency lights in the arena area to meet the current code. Currently all exit signs are older style "exit" signs.

- Replace exit signs with the updated green “running man” (pictogram) style signs as required per National Building Code-2019 Alberta Edition Section 3.4.5.
- Add new emergency lights in the arena area to meet 5 lux on stairways and main egress.

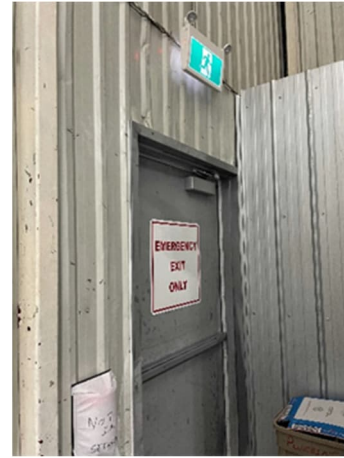
Figure 5-21 Modernized Emergency Light - Battery Combo

Emergency lighting is installed throughout the building. The emergency lighting levels throughout the facility were not tested; however, it appears all main egress paths are lit as per National Building Code-2019 Alberta Edition Section 3.2.7.3 "Emergency Lighting". Most of the emergency lights are battery combo or battery/exit sign combo and were replaced, likely more than 10 years ago. It is recommended to replace the remaining emergency lights and exit lights in the next 3 to 5 years.
